Technical Services Committee

Business Paper for July 2020

Conservation and Management Guidelines

2018 CONSERVATION PLAN

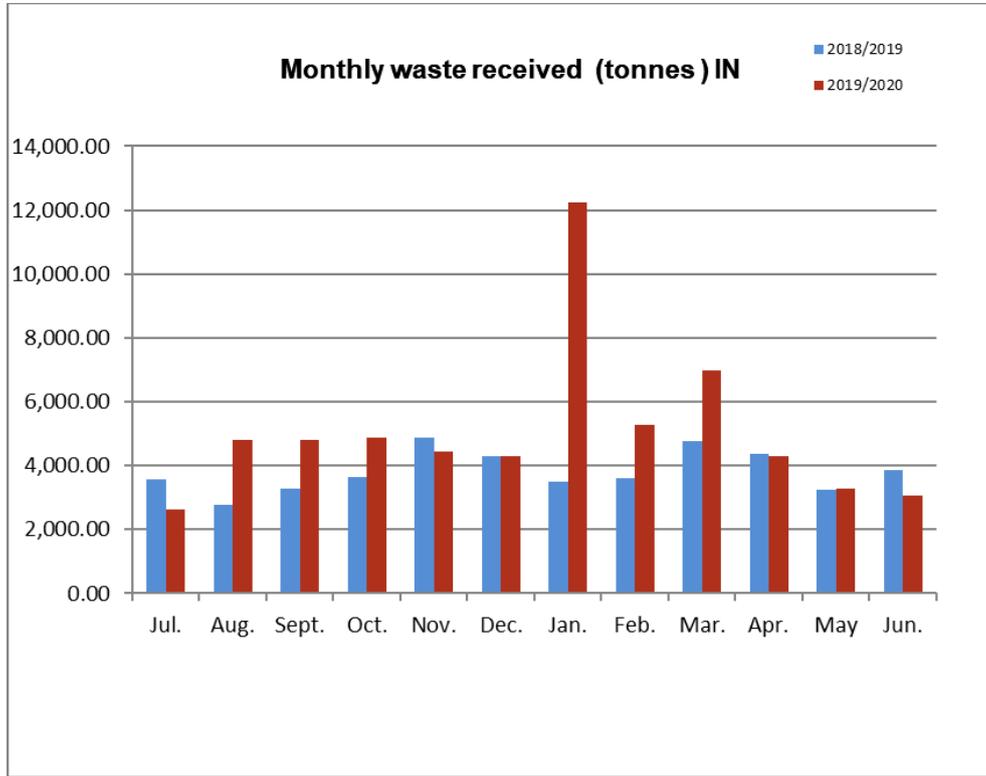
Figure 1: Monthly waste comparison by financial year (tonnes) received (IN)

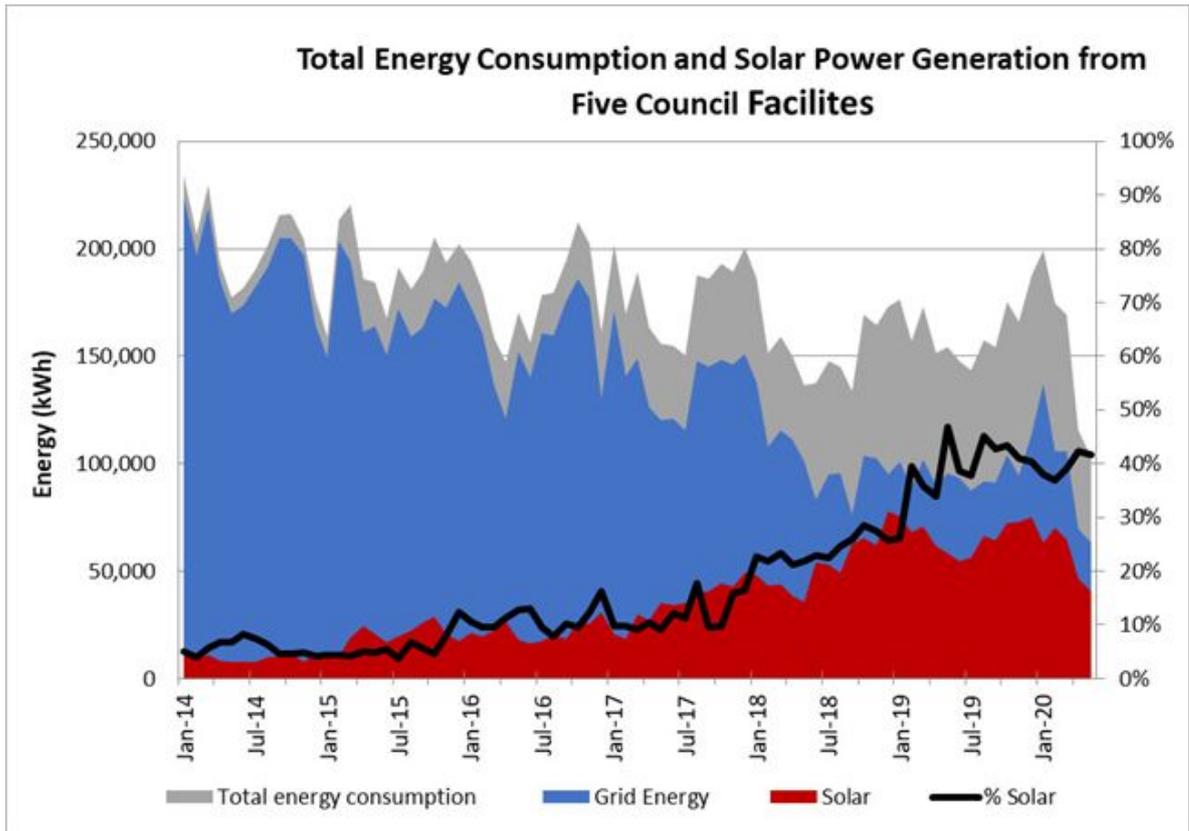
Figure 3. Total energy consumption, grid energy supplied, and solar energy produced combined for the ASALC, Civic Centre, Depot, RWMF and Library

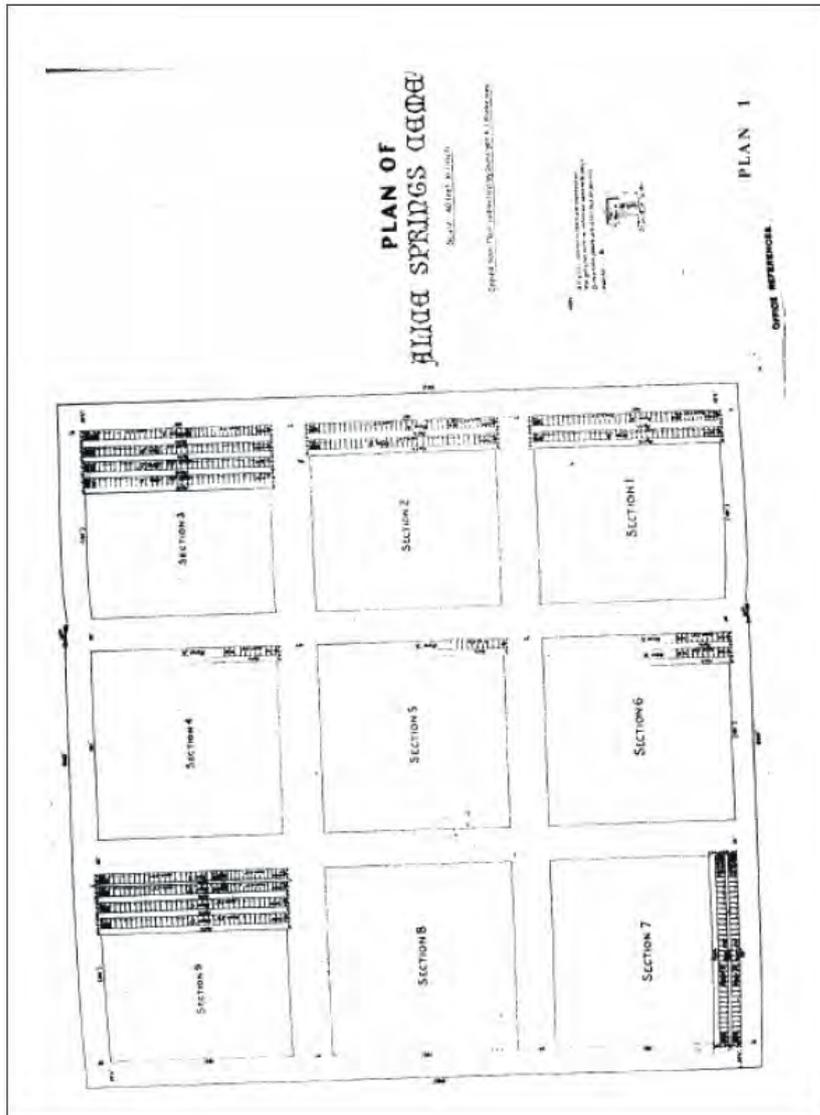
Figure 1. Plan of the Cemetery based on Blakeway's Plan.
Source: Strong 1995

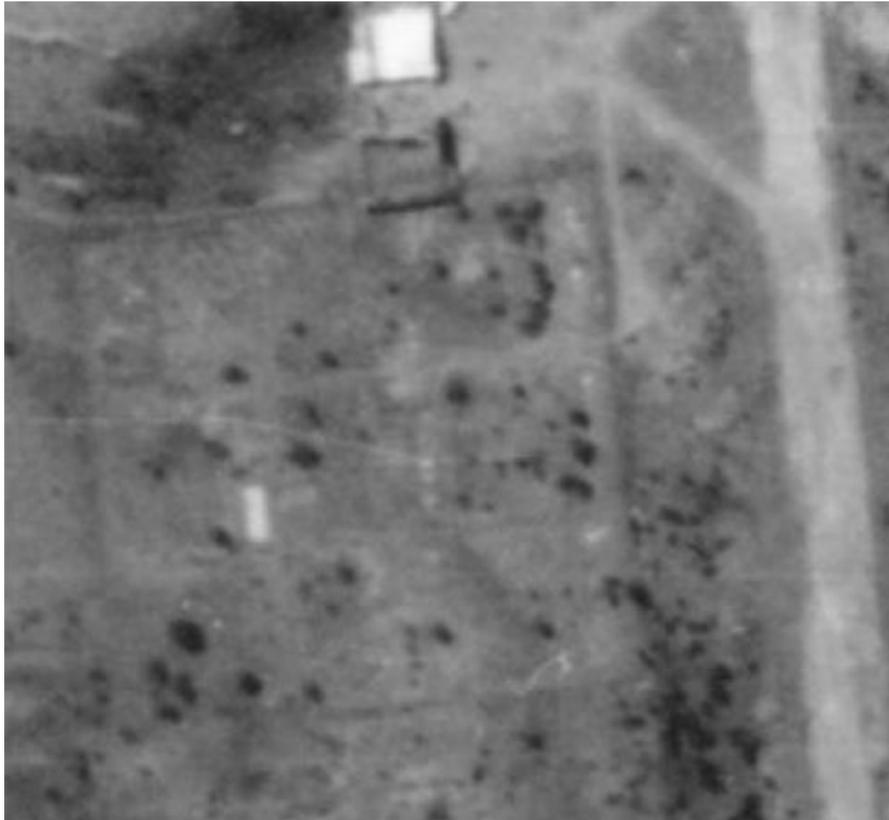
Plate 4. Aerial view over the Cemetery (enlarged), 1948. Connellan Hangar visible at top.
 Source: SVY350, Run 5, Frame 5040, 1948.
 Courtesy Land Information, Department of Infrastructure, Planning and Logistics

Other photographs from the Richard Duckworth Collection which feature Central Australia and which may have been taken around the same time, are dated September 1947¹²⁹ so it is possible these two photographs were also taken around that time. Further supporting evidence is visible on a 1948 aerial over the area (Plate 4). Plate 4 (below) shows that the Cemetery was sparsely vegetated in the late 1940s. What appears as a white rectangular feature in Section 8 corresponds to the location of the War Cemetery and is consistent with the type of grave makers shown in Duckworth's photographs.

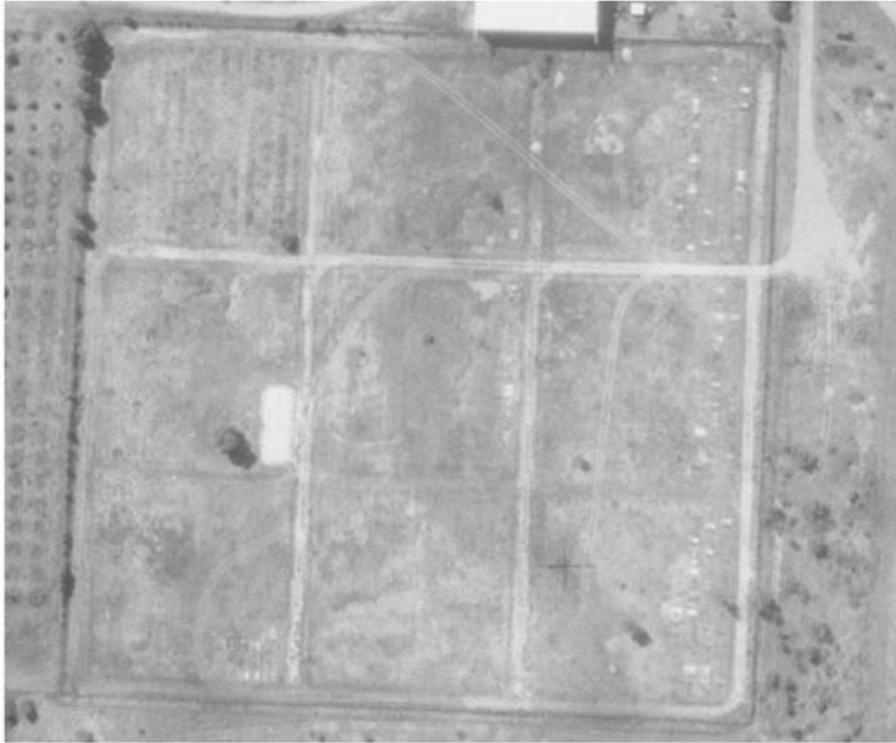
Plate 9. Aerial view over the Cemetery (enlarged), 1955.
Source: CAG 1020, Run 5, Frame 5A-15, 1955.
Courtesy Land Information, Department of Infrastructure, Planning and Logistics

A 1955 aerial photograph over the Cemetery attests to the barren nature of the Cemetery at this time (Plate 9). Many of the individual shrubs visible on the 1948 aerial photograph can no longer be seen by 1955. Whether these shrubs were cleared in order to make way for burials as the Cemetery progressively filled or whether they died owing to dry conditions or combination of the two, is unknown. Two other features stand out on this aerial: the War Cemetery and vehicle tracks cutting across some of the Sections. A photograph taken sometime between 1950 and 1956 (Plate 10) shows an unimpeded view from the northeast corner of the Cemetery towards Mt Gillen; a few raised burial mounds with white markers are visible in what appears to be a grassed paddock surrounded by a simple wooden post and wire fence. Such views across to the MacDonnell Ranges and Mt Gillen were part of the Cemetery’s setting for many years, up until the time that it was surrounded by housing development. The effect in the early days, was one of people laying their loved ones to rest in the shadow of the Ranges, as a report on the funeral of G.A. Johannsen in 1951, one of the biggest in Alice Springs for many years indicates: “[he was buried] in dusty arid Alice Springs Cemetery under the shadow of Mount Gillen. The scene typified the country which “Pop” loved and served for more than 40 years”¹⁴⁹.

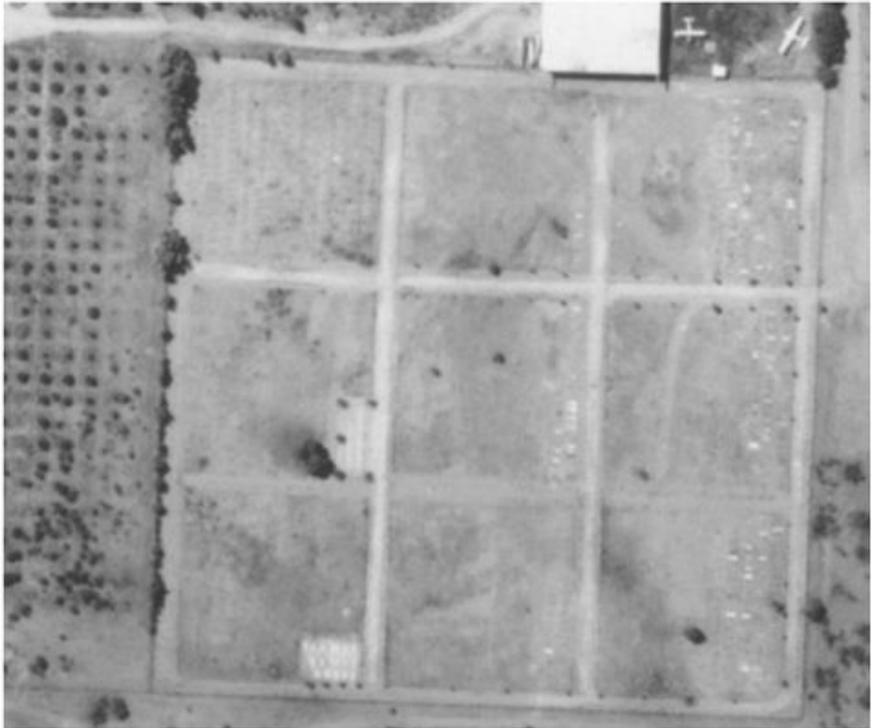
Plate 11. Aerial view over the Cemetery (enlarged), 1959.
 Source: CAG 3027, Run 5, Frame 5105, 1959.
 Courtesy Land Information, Department of Infrastructure, Planning and Logistics

The 1959 aerial photograph indicates that along the main east-west avenue the plantings were spaced such that there were five per Section, whilst along the southern sides of Sections 1 and 6 and eastern boundaries of the Cemetery the plants were spaced so that there were four per Section. Physical evidence on-site today, suggests that these earliest plantings were probably White Cedars (*Melia azedarach*). Other plantings which had occurred by this time includes four plants on the southern boundary of Section 7A (the “Mohammedian” section), and five plants around the War Cemetery: one in each corner and one in the centre of the western boundary.

It is possible that sometime between 1955 and 1959 water may have been supplied to the Cemetery; whether this was actually piped to the site at this time or whether water was simply carted to the Cemetery on a periodic basis is unclear, given that in 1959 there were still no public amenities on site. However, by 1959 plantings had occurred along the main east-west avenue between Sections 2 and 3, 4 and 5, and 8 and 9, the eastern boundary, southern boundaries of Sections 1, 6 and 7A, and around the Alice Springs War Cemetery (Plate 11).

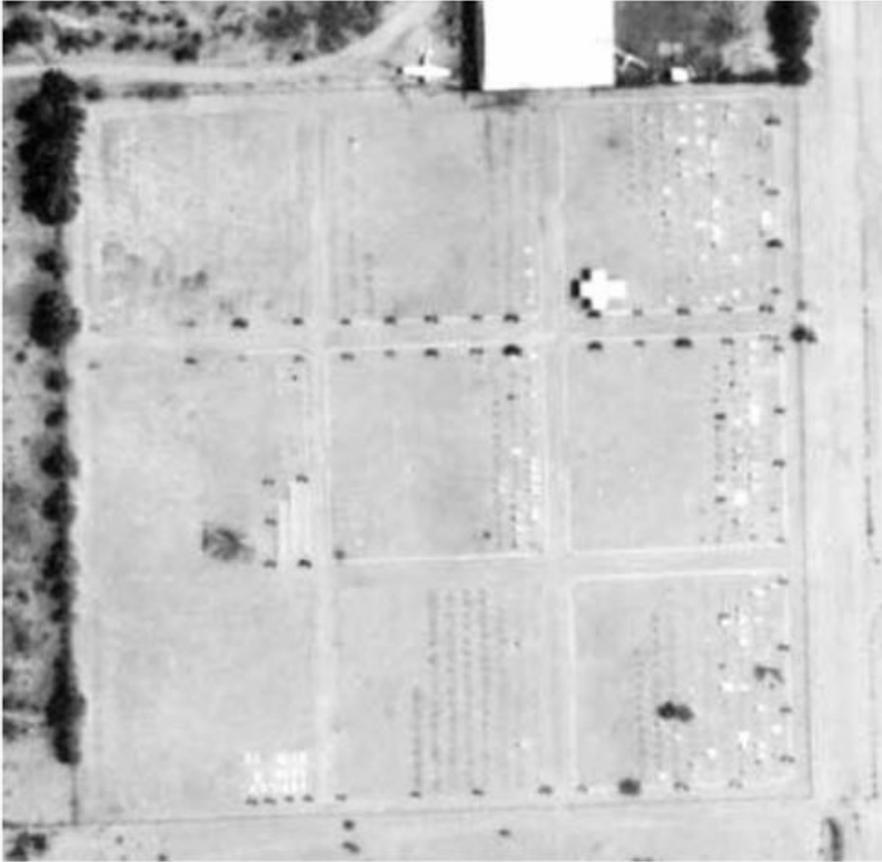
Plate 12. Aerial view over the Cemetery (enlarged), 1964.
 Source: CAG 194, Run 8, Frame 5236, 1964.
 Courtesy Land Information, Department of Infrastructure, Planning and Logistics

Despite the drought conditions that prevailed in Central Australia between 1958 and 1967¹⁵⁶, the plantings in the Cemetery appear reasonably well established by 1964. Additionally, a Cemetery Lodge had been constructed by this time, in the southeast corner of Section 3 (Plate 12).

Similarly to today, it is likely that the Lodge housed toilets in the western half of the building with space for gardening and other equipment in the eastern part of the structure. The Lodge is simple in terms of its design and materials which probably reflects the available funding for its construction at that time. Aerial photographs suggest that the first Sections that were enclosed with perimeter kerbing were Sections 1, 2, 3 and 5, and that this kerbing was laid sometime between 1959 and 1964 at the latest.

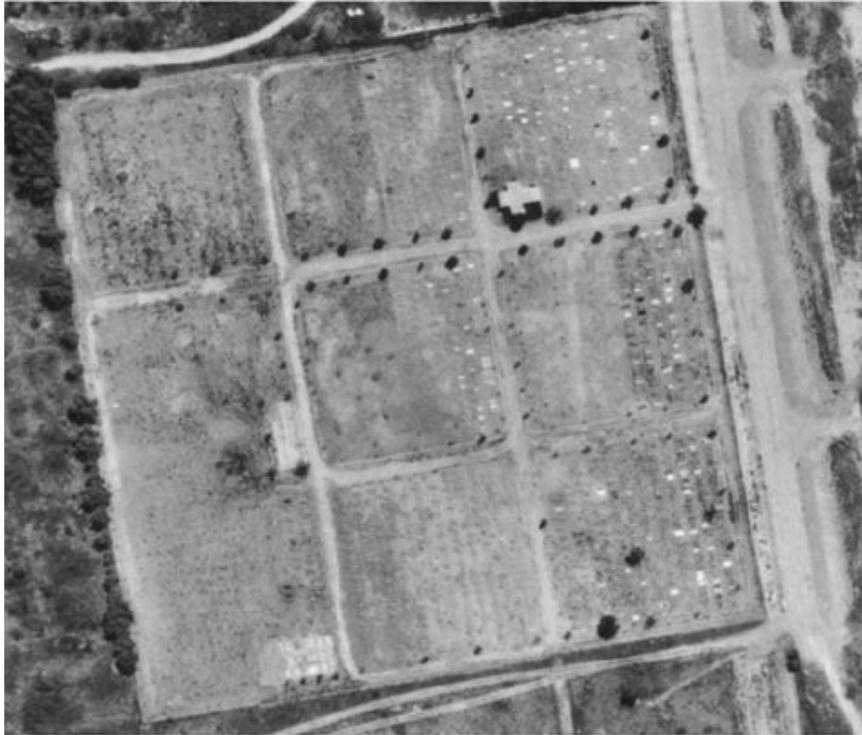
Plate 14. Aerial view over the Cemetery (enlarged), 1968.
 Source: CAG 3639, Frame 1227, 1968.
 Courtesy Land Information, Department of Infrastructure, Planning and Logistics

By 1968 additional plantings are visible along the borders of Sections 1, 2, 3, 5, 6 and 8 (Plate 14). The spacing of these plantings maintains the earlier design i.e. five plants per east-west section length except along the Cemetery boundaries. Plants along the north-south edges of Sections appear to have six plants per section length. Note these aerials

also show what appears to be the existing Corkwood tree in Section 1 as well as the large peppercorn tree part way along the southern boundary of this Section.

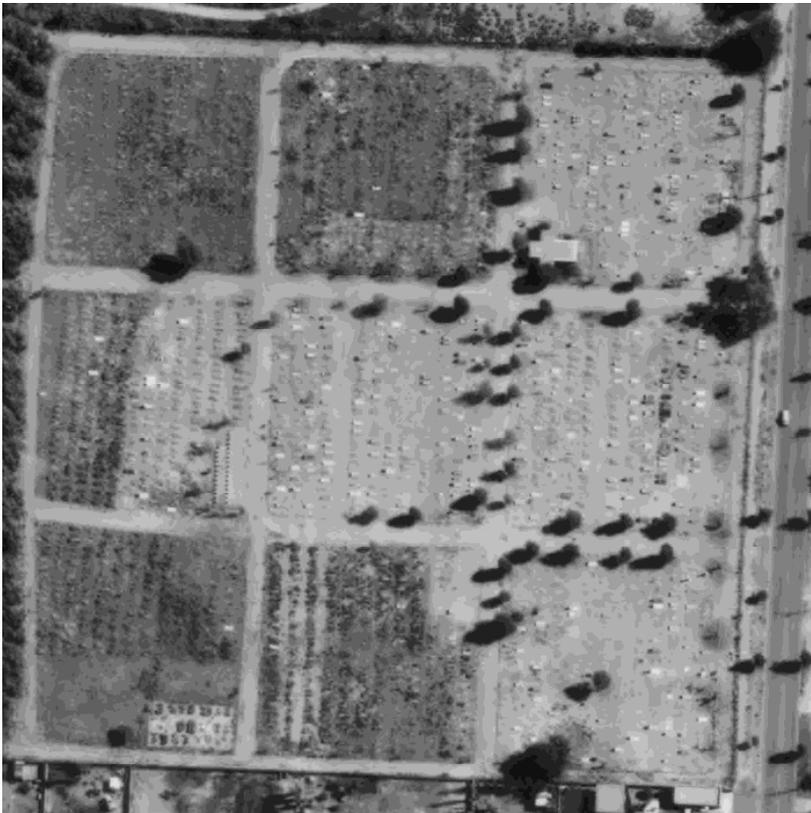
Plate 16. Aerial view over the Cemetery (enlarged), 1978.

Regular burials in the General Cemetery continued up until mid 1978, with the majority thereafter occurring at the Alice Springs Garden Cemetery. The General Cemetery was not formally closed until April 1995¹⁶⁸. Exceptions have been made for reserved plots in which burials occur intermittently¹⁶⁹. The 1978 aerial photograph shows the Cemetery to be virtually full (Plate 16). No additional plantings appear to have occurred. The large tree immediately east of the peppercorn on the southern boundary of Section 1 and visible in May 1975 seems have disappeared by October 1978. The avenue itself between Sections 7 and 8 appears to curve towards the north at its western end and the burials in Section 8B are not in straight lines relative to the section boundaries.

Most noticeable on the 1982 aerial photograph is that the ground surface in Sections 4, 6, 7 and 9 has been levelled as the distinct rows of burial mounds evident in the 1978 aerial are no longer visible. A photograph of Namitjira's original headstone (Plate 13) taken in 1963 shows his plot in Section 6 surrounded many simple mounds of dirt; the same area in 1982 and today demonstrates no obvious physical evidence of these burials.

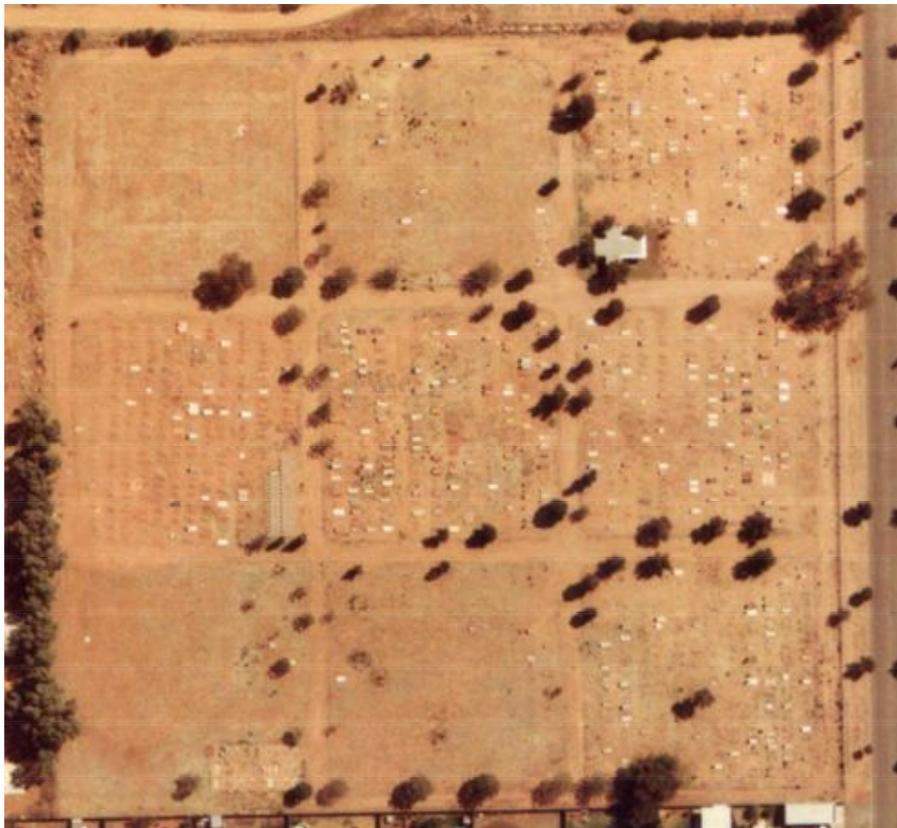
Plate 17. Aerial view over the Cemetery (enlarged), 1982.
 Source: NTC172, Run 7, Frame 079, October 1982.
 Courtesy Land Information, Department of Infrastructure, Planning and Logistics

By the beginning of October 1982 the earliest plantings along the eastern boundary of the Cemetery, adjacent to Sections 1 and 2, had been removed (Plate 17) as had some of the Kurrajongs planted in the 1970s. Overall, the planting design which was clear in 1968 and 1978 does not seem as obvious by the early 1980s. Outside of the Cemetery, most of the trees along the northern half of the western boundary had disappeared. By 1985 most of the remaining trees along the western boundary had also been removed.

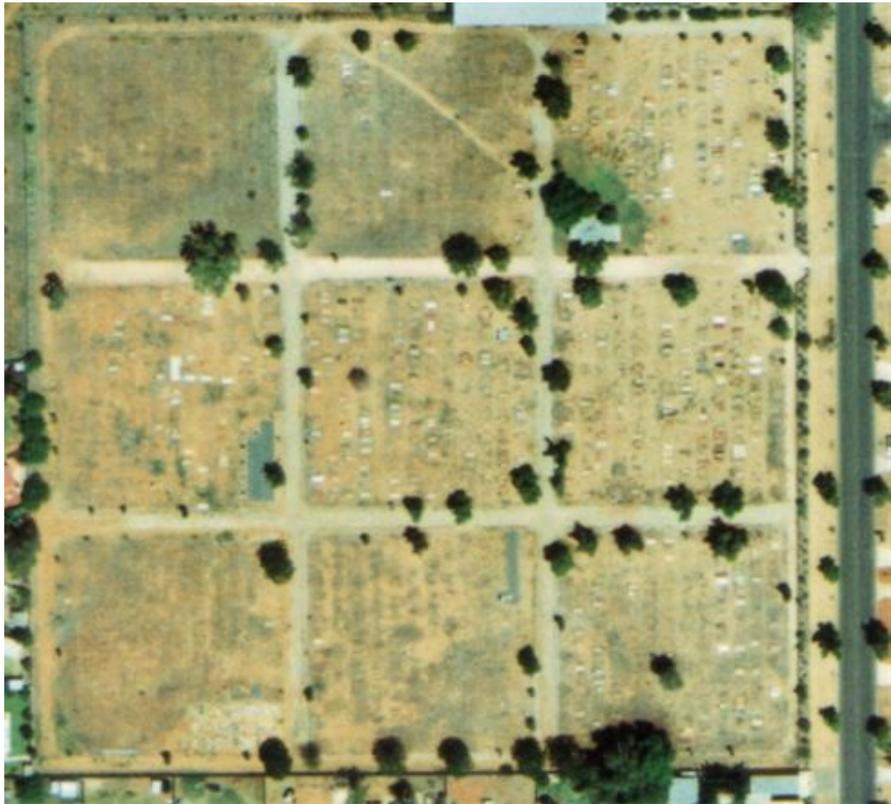
Plate 18. Aerial view over the Cemetery (enlarged), 1996.
 Source: NTC1305, Run 1, Frame 118, January 1996.
 Courtesy Land Information, Department of Infrastructure, Planning and Logistics

By 1996 the surrounds to the War Cemetery had been filled in with blue metal, and a cracker dust path to Albert Namatjira's grave had been created (Plate 18). His original and relatively modest headstone had been replaced by the current monument although this may have occurred prior to October 1982. Un-marked burials in Section 8B also appear to have been levelled. Some of the older plantings had disappeared although it seems that some new ones had occurred on the western boundary of the Cemetery, adjacent to Sections 7 and 8, and along the east-west avenue between Sections 7 and 8. The spacing of these plants does not seem to quite match earlier planting episodes being placed slightly closer together. A small area of green grass was established around the Cemetery Lodge. Additionally, the curve at the western end of the avenue between Sections 7 and 8 had been straightened and this probably occurred at the same time that the ground levelling works were carried out between 1978 and 1982.

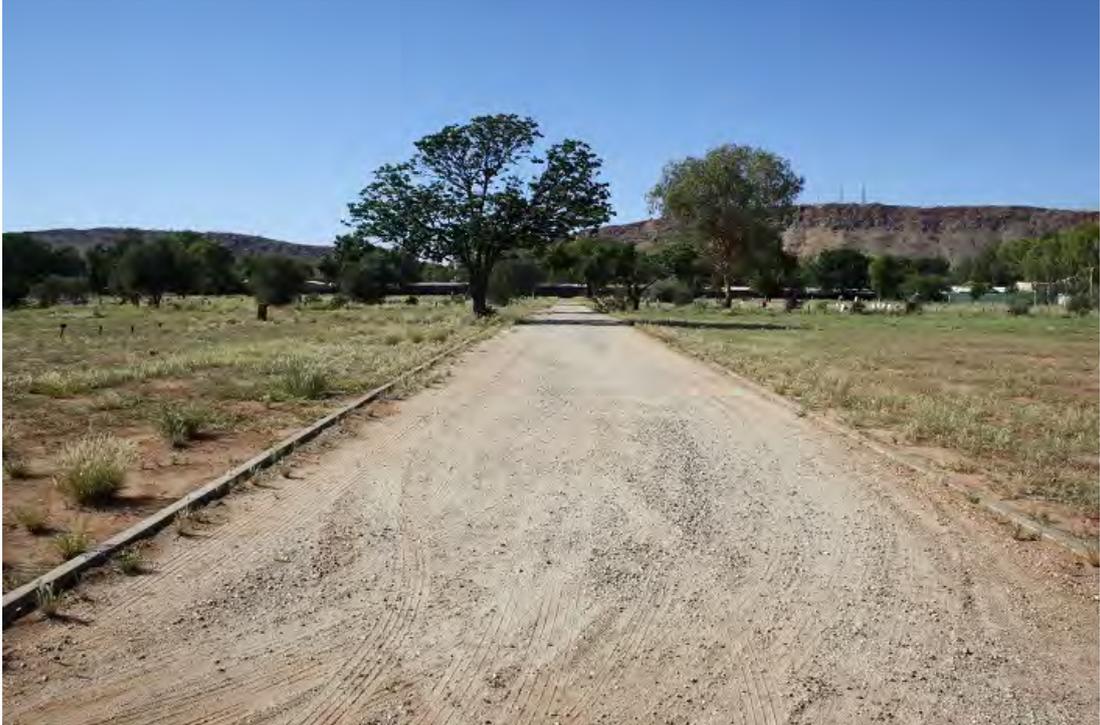
Plate 19. View south along the north-south Avenue between Sections 4 and 9.

The Alice Springs General Cemetery comprises a square area divided into a grid pattern of nine Sections, each separated by east-west and north-south avenues of compacted gravel and earth (Figure 3). Each Section measures 181' (55.2m) east-west x 180' (54.9m) north-south. The north-south avenues between each Section are 33' (10m) in length, whilst the east-west avenues between each Section are 37' (11.3m) long. These avenues join to form a series of longer east-west and north-south avenues running across the Cemetery from one side to the other (e.g. Plates 19-20).

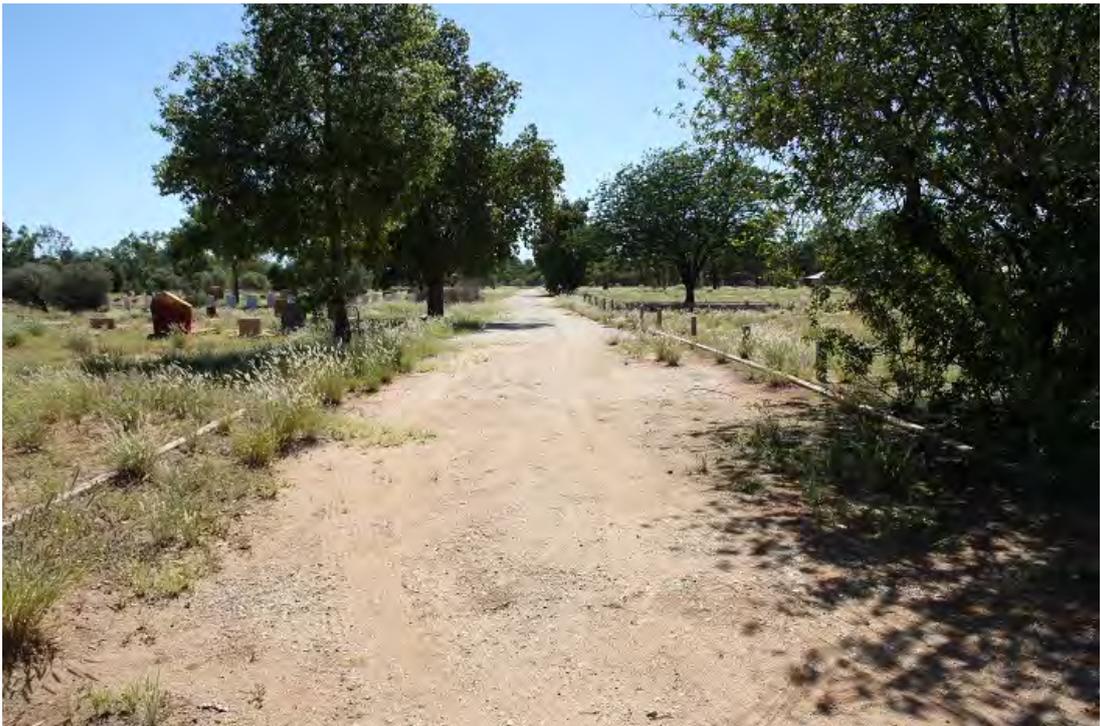
Plate 20. View east along the east-west Avenue between Sections 7B and 8B.

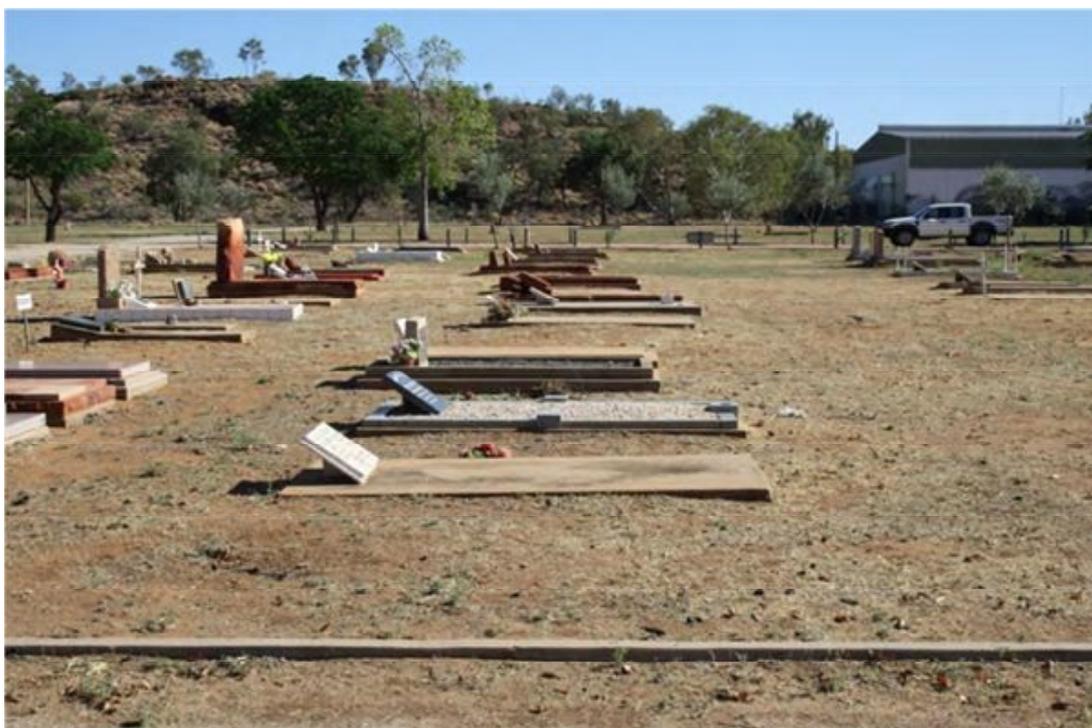
However, there are exceptions to this general layout. For example, the width of some plots (e.g. in areas of Sections 1, 3 and 7); the division of some Sections into Sub-sections (e.g. Section 2 into 2A and 2B between Rows G and H; Section 5 into 5A and 5B between Rows H and I; Section 7 into 7A and 7B; and Section 8 into 8A, 8B¹⁷² and Stillborns). Other exceptions include the east-west alignment of rows Section 7A (the Mohammedan section), and inclusion of the Lodge in Section 3¹⁷³ (Figures 4-12). It is also clear from aerial photographs taken in the 1970s that the alignment of the graves in Sections 7B and 8B, as well as Sections 2A and 5A is not a straight north-south alignment matching the north-south alignment of the section boundaries. For example, the westernmost rows in Sections 7B and 8B tend to veer off in a easterly direction, while Row I of Section 5A has a distinct curve in it. Rows I-L inclusive of Section 5A also tend to veer off towards the north-northwest, rather than remaining in straight north-south rows relative to the section boundary (Plate 21).

Plate 21. View north along Section 5A, Row J 2013.
 Note: 2013 photograph selected to show the misalignment more clearly.

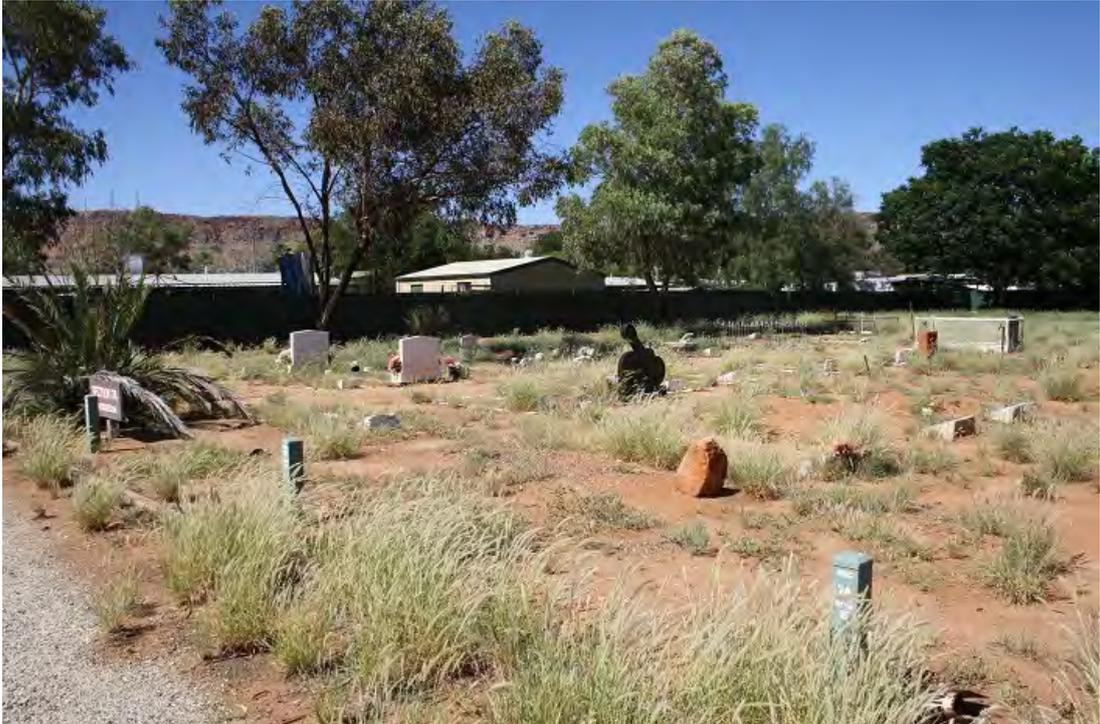
Plate 22. View southwest across Section 7A ("Mohammedan") where graves are orientated north-south rather than east-west.

Whilst the Cemetery primarily demonstrates the Christian tradition of graves facing the rising sun, there are exceptions. In the Section 7A (“Mohammendan”) the graves are orientated north-south rather than east-west (Plate 22). Olive Pink’s grave in Section 4 faces west

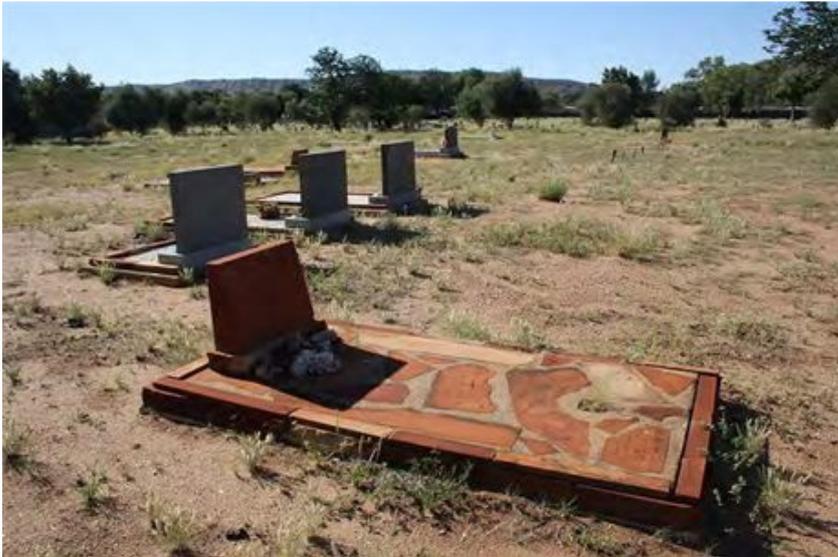
Plate 23. Olive Pink's grave Section 4 (foreground) faces west, rather than east.

looking towards Mt Gillen rather than east (Plate 23), in accordance with her wishes¹⁷⁴. Jean McCleod's headstone in Section 2B Row A also faces west¹⁷⁵.

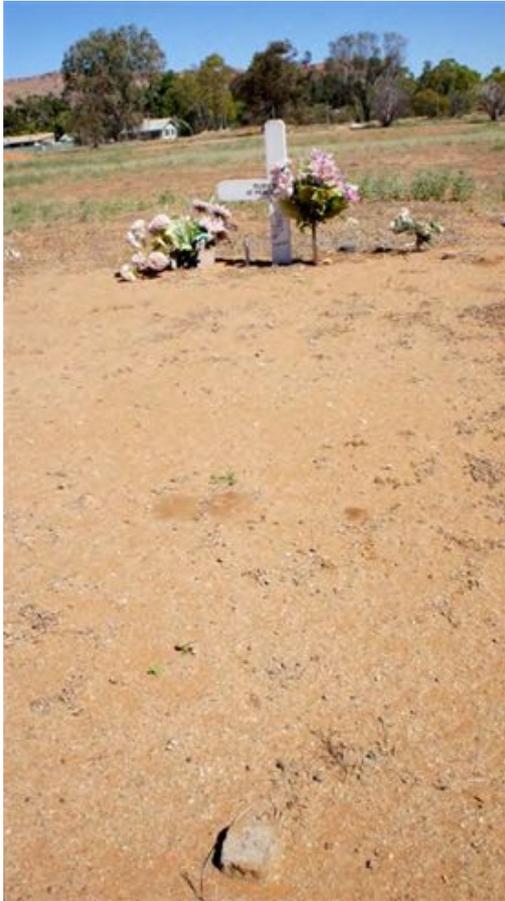
In 1995, some of the early surveyed plots were still marked with small re-enforced concrete pegs, particularly in Section 3. Whilst these do not appear to have survived in this section today, other examples still remained *in situ* in Section 7B and in Section 9 Row C around Ruby Briscoe's grave in 2013 (Plate 24) but could not be located in 2018. Some plots were also marked with numbers in the form of small oval black and white enamel markers, few of which remain¹⁷⁶ (e.g. Plate 25). A few earlier signs designating reserved plots still survive scattered throughout the Cemetery and in a row of four in Section 4 Row J. These signs consist of metal markers with 'RES' painted in white (Plate 26), whereas some other metal signs have 'RESERVED' painted in black on white (e.g. see Plate 25 above). Elsewhere, some of the reserved signs have been replaced with low concrete plinths, marked with an 'R' (Plate 27).

Plate 24. Example of small reinforced concrete Peg (foreground), Ruby Briscoe's grave, Section 9 Row C. 2013 image; no sign of this peg remained in 2018.

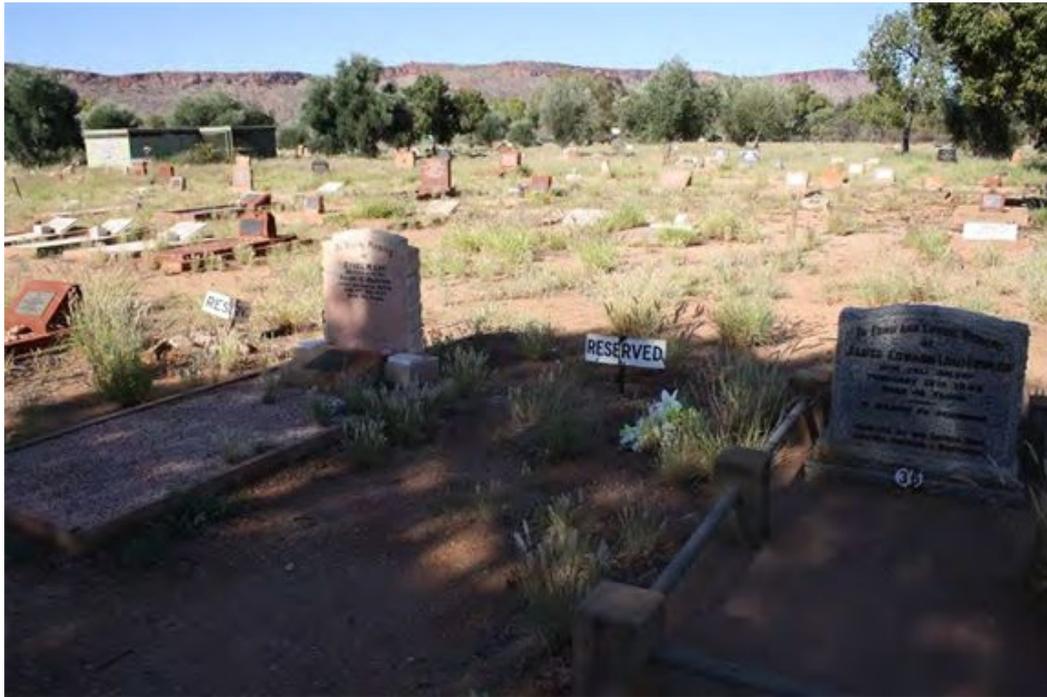
Plate 25. Examples of plot markers in Section 3 Row C. Reserved markers (middleground and far left) and early round enamel marker "36" at base of headstone (right).

These are simple markers comprising a number painted on an oval-shaped enamel tin plate and attached to another form of grave marker. An example of this type of marker appears in Plate 25.

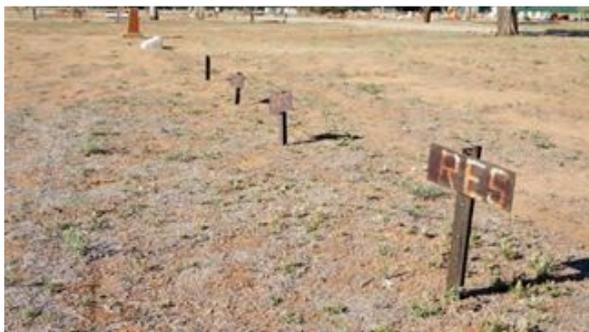
Plate 26. Examples of early plot markers, Section 4 Row J.

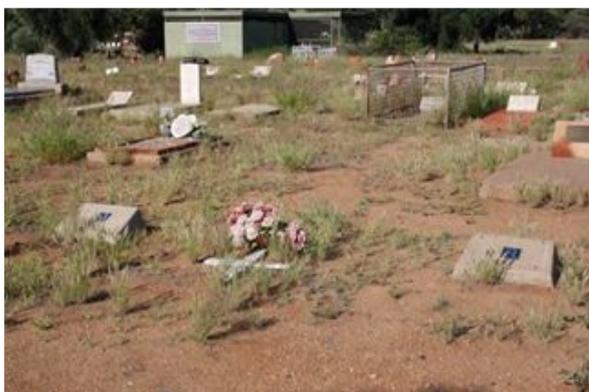
Plate 27. Examples of more recent plot markers, 'R', Section 3 Row B.

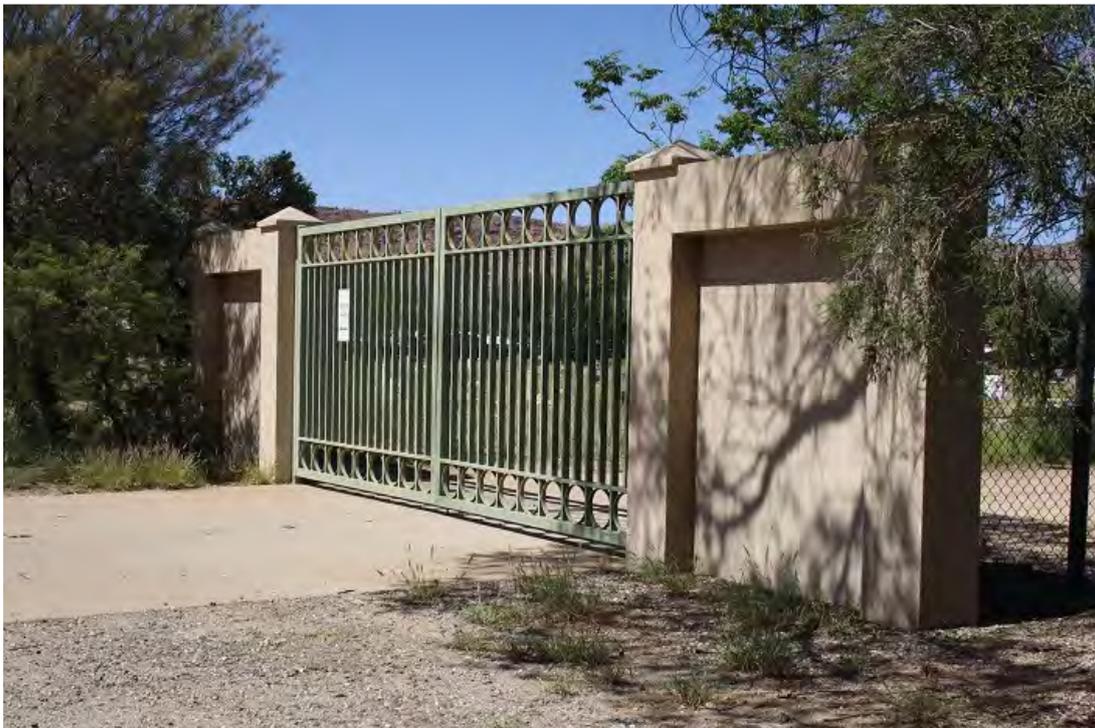
The main Memorial Avenue entrance consists of pre-formed concrete block panels rendered and painted on both sides of the 1.8m high steel gates, and a pedestrian entrance on the southern side (Plates 28-29). There is a smaller entrance along the northern boundary which previously provided access to/from the Aviation Museum and Araluen Precinct, but is now kept locked. There is also another locked gate along the northern boundary fence, west of the Hangar.

Plate 28. Entrance to the Alice Springs General Cemetery.

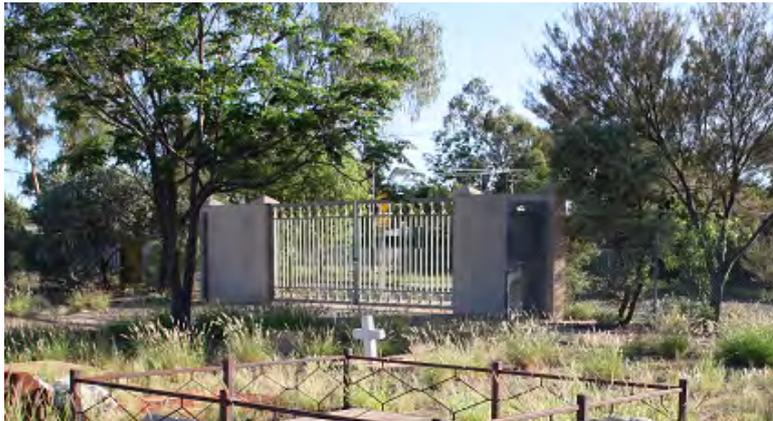
Plate 29. Entrance to the Alice Springs General Cemetery, showing pedestrian entrance at the right.

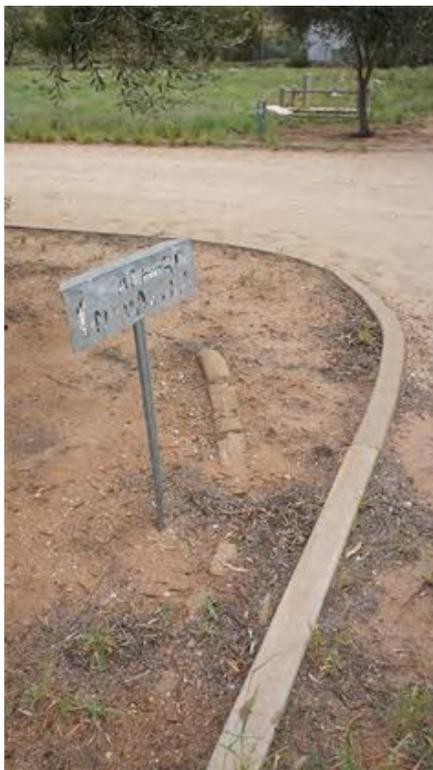
Plate 30. Perimeter kerbing and evidence of earlier kerbing, north-east corner of Section 5B.

Except for the western boundary of Sections 7, 8 and 9, each section is bordered by perimeter kerbing. This takes the form of a low, un-painted concrete kerb, about 100mm wide. The corners of each section are not sharply defined, rather they are rounded off and hence the kerbing is also rounded on each corner. There is some evidence of earlier kerbing on the northeast corner of Section 5B (Plate 30). Some corner sections have been damaged owing to vehicular traffic attempting to negotiate tight corner turns (e.g. along the southern and eastern boundaries of the Cemetery and northwest corner of Section 4, Plate 31). In contrast, the earlier kerbing was of a more generous radius than the current tight quarter circle turns.

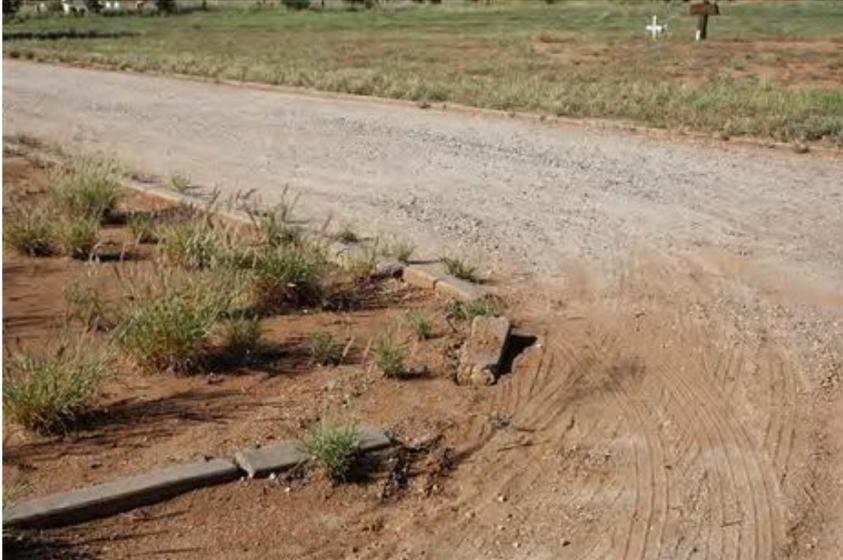
Plate 31. Damage to kerbing from vehicle traffic, northwest corner of Section 4.

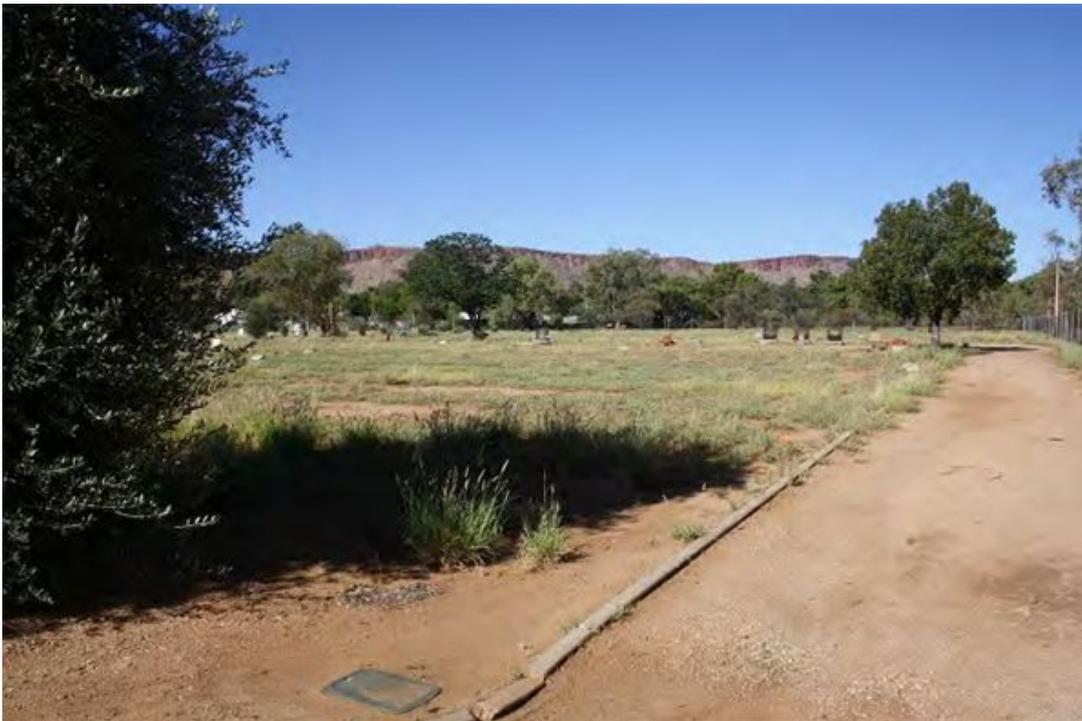
Whilst the east-west and north-south avenues consist of compacted earth and gravel, the thoroughfares around the perimeter of the Cemetery are mainly compacted earth (e.g. Plate 32).

Plate 32. Compacted earth thoroughfare along the northern edge of the Cemetery, adjacent to Section 4.

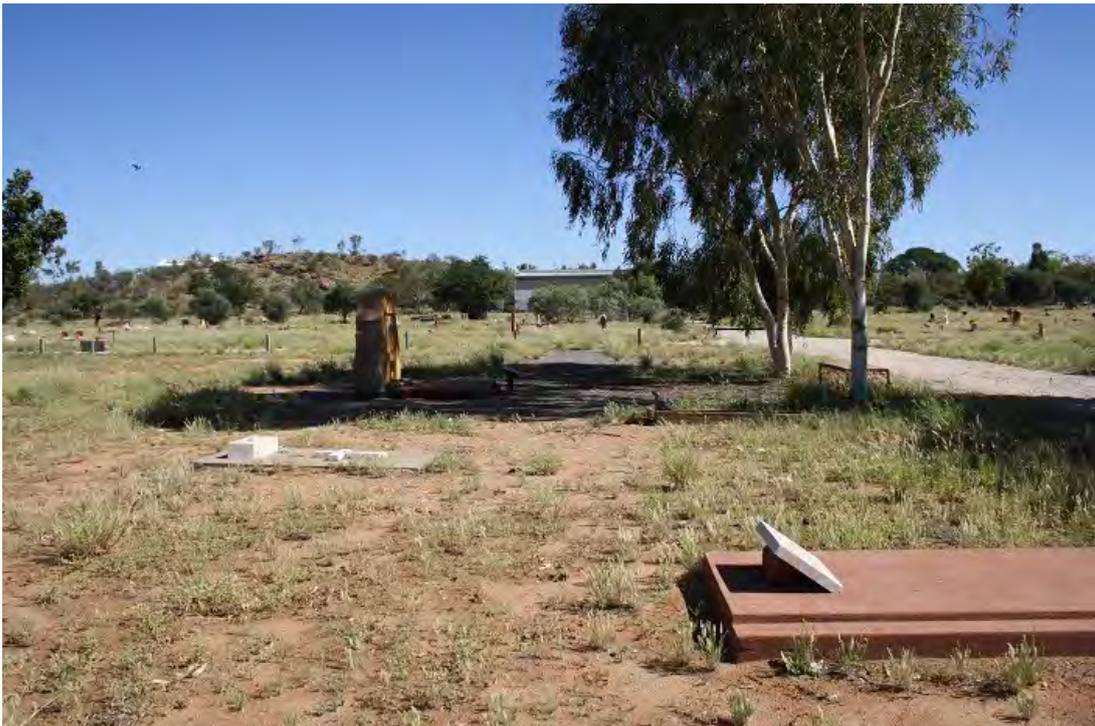
grave; this consists of blue crackerdust which may extend over the top of some plots. The second is the southern part of the path between Sections 2A and 2B, which has also been laid with crackerdust. In relation to Albert Namatjira's grave it should also be noted that the current location of the bench seat relative to his grave (Plate 33) may suggest to visitors that there are no burials between the seat and his grave. This is not the case according to aerial photographs taken in 1964. The two Eucalypt trees on either side of the bench are thought to have been planted around the same time the bench seat was installed, probably around the mid-2000's as the work looks to be recent in a 2006 photo (Plate 34). In contrast, aerial photographs indicate the crackerdust path was laid in or prior to, 1982.

Plate 33. View north to Albert Namatjira's grave, Section 6 Row B (middleground). Crackerdust path to his grave (centre middleground), his grave (at left), twin ghost gums and bench (at right).

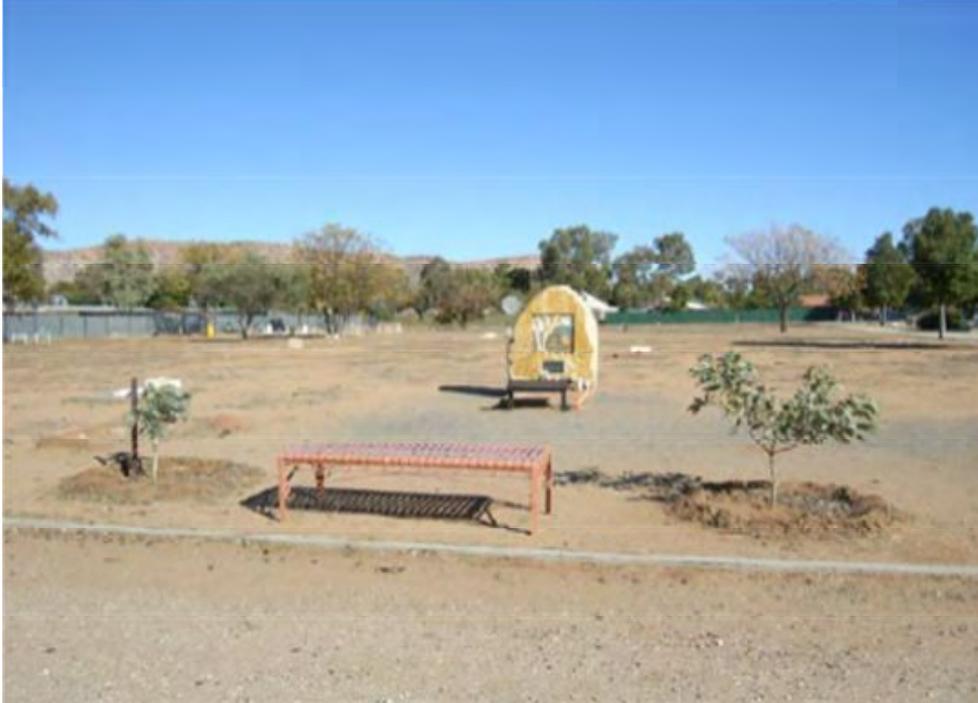
Plate 34. View west to Albert Namatjira's grave, 2006.
The bench seat and plantings on either side appear to be relatively recent additions at this time.
