Technical Services Committee

Business Paper for July 2020

Conservation and Management Guidelines

2018 CONSERVATION PLAN

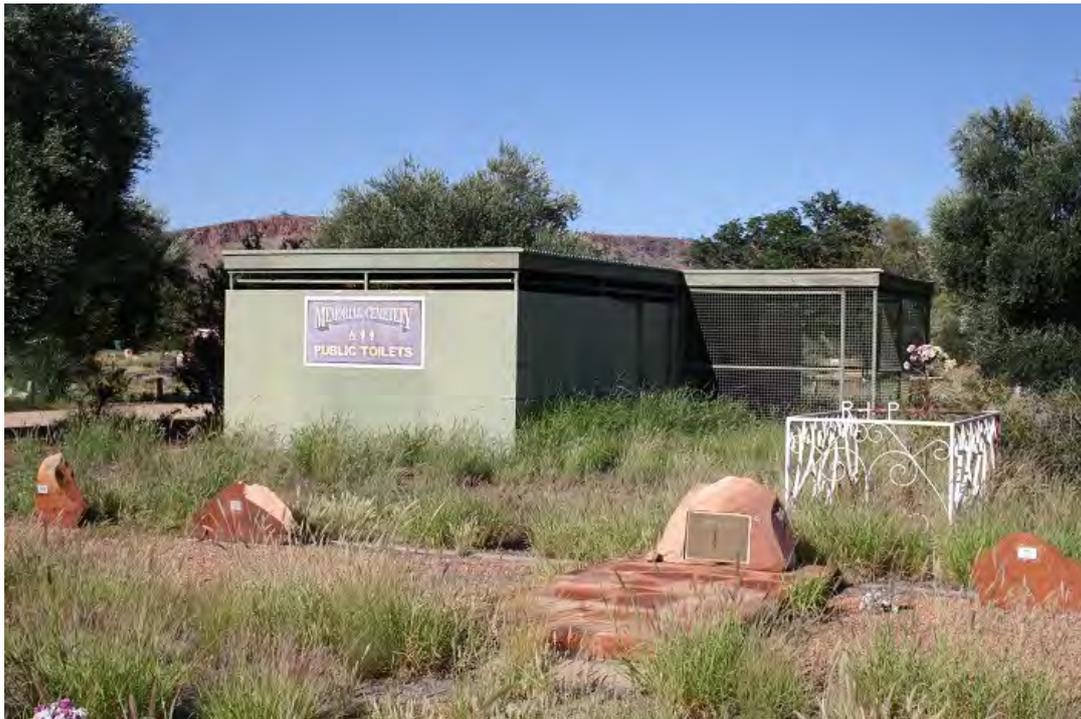
The Cemetery Lodge is designed upon a crucifix plan, comprising a central shaded breezeway area, flanked to the west by toilet facilities and a storage room to the east. It is constructed of painted face blockwork on a concrete slab, with steel pipe frame supporting the flat roof structure of timber rafters, sheeted in zinc-plated (zincalume) cladding of a profile similar to Lysaught Spandek. Steel mesh walls and doors enclose the verandah spaces (Plate 36). This building is thought to be the same building that was constructed sometime between 1959 and 1964. Note that part of the roofing over the storage room seems to be of a different period to the initial construction, given it is of a different sheeting (Plate 37). Generally, the building is in a poor condition.

Plate 36. View southwest to the Cemetery Lodge.

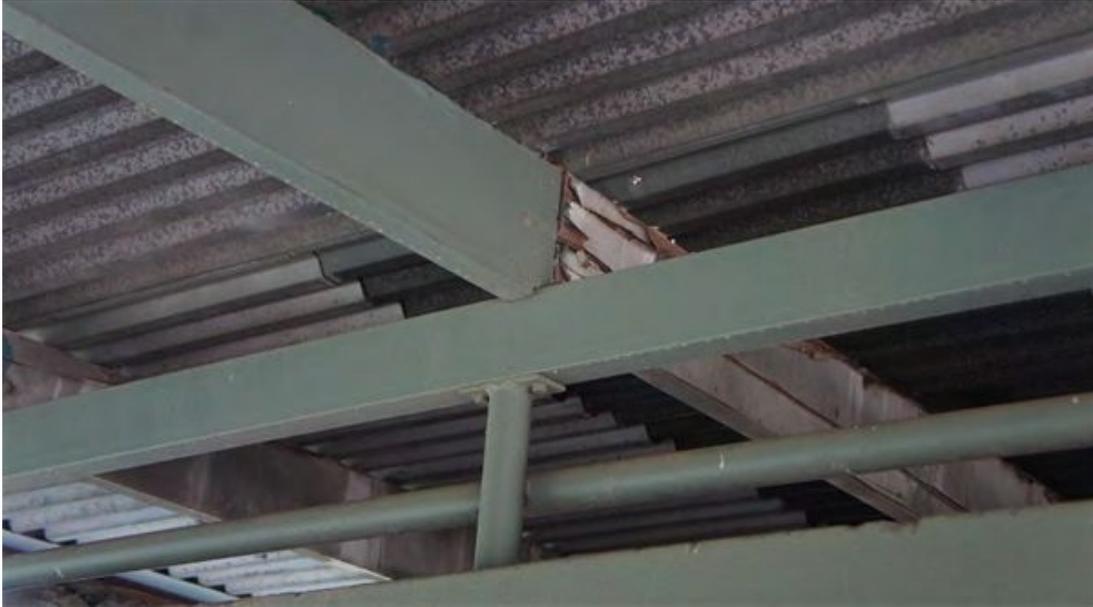
Plate 37. Detail of different roof sheeting to the Cemetery Lodge.

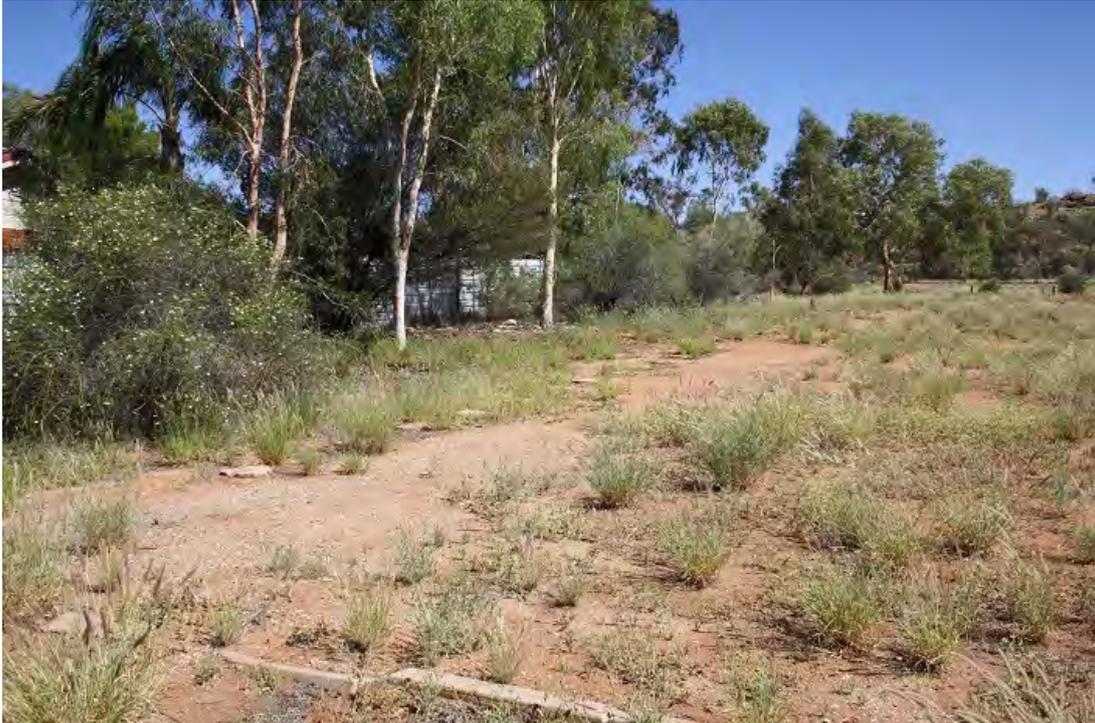
The Peace Garden Memorial lies along the western boundary of the Cemetery adjacent to Section 8. As noted in part 3.2 above, the intent of this work was to create a memorial for the Stillborn section. It consists of plantings of native species, large elliptical-shaped curved concrete slabs in contrasting colours and over 40 leaf-shaped concrete pavers placed along the ground (Plates 38-39). The location of these concrete markers does not necessarily accurately reflect the location of burials in this Section.

Plate 38. View northeast towards the Peace Garden Memorial and Section 8 (Stillborn), 2018.

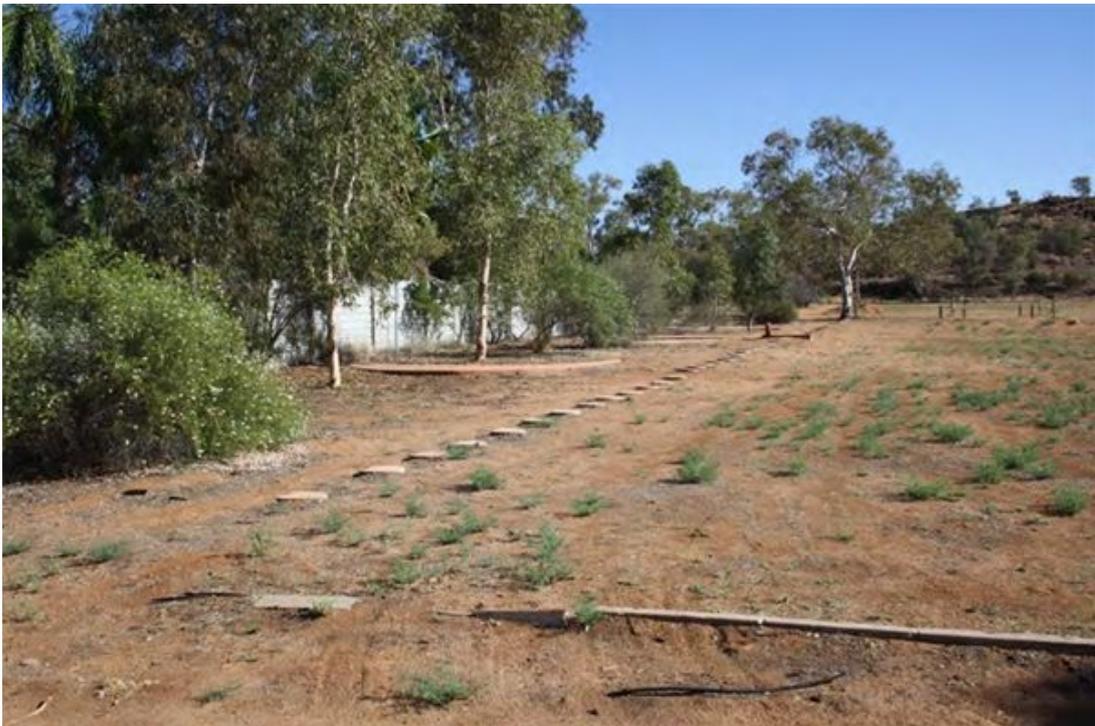
Plate 39. View northeast towards the Peace Garden Memorial and Section 8 (Stillborn), 2013. The 2013 image is shown here to illustrate the different elements of the Memorial more clearly.

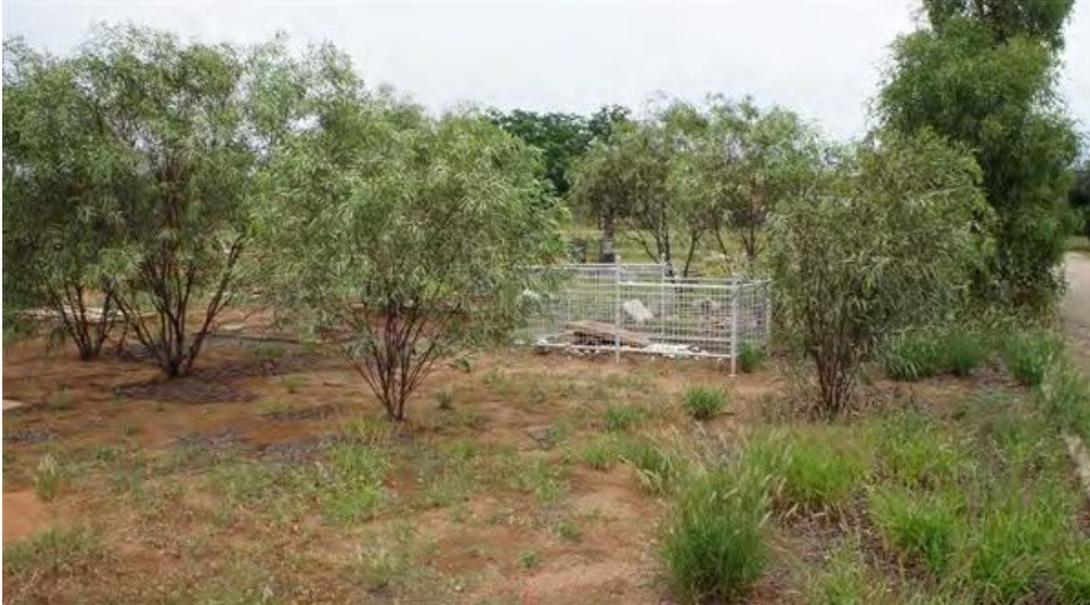
Other Australian native species in the Cemetery include Eucalypts, Kurrajongs, Desert Cassias, Acacias and Bottlebrush. All have been introduced within the post-1960s period. Some smaller specimens do self-seed, for example those adjacent to the northern end of Section 5B Rows A and B (Plate 44).

Plate 44. Examples of self-seeding Acacias in Section 5B, Rows A and B, 2018.

An example of self-seeded vegetation that has invaded grave plots is evident in Section 5B Rows A and B (see Plate 44). An example of past planting that has affected the built fabric of the Cemetery is evident along the perimeter of Section 8B Row F, while an example of more recent inappropriate plantings that have the potential to damage grave plots in future is evident in Section 5A Row I (Plate 80).

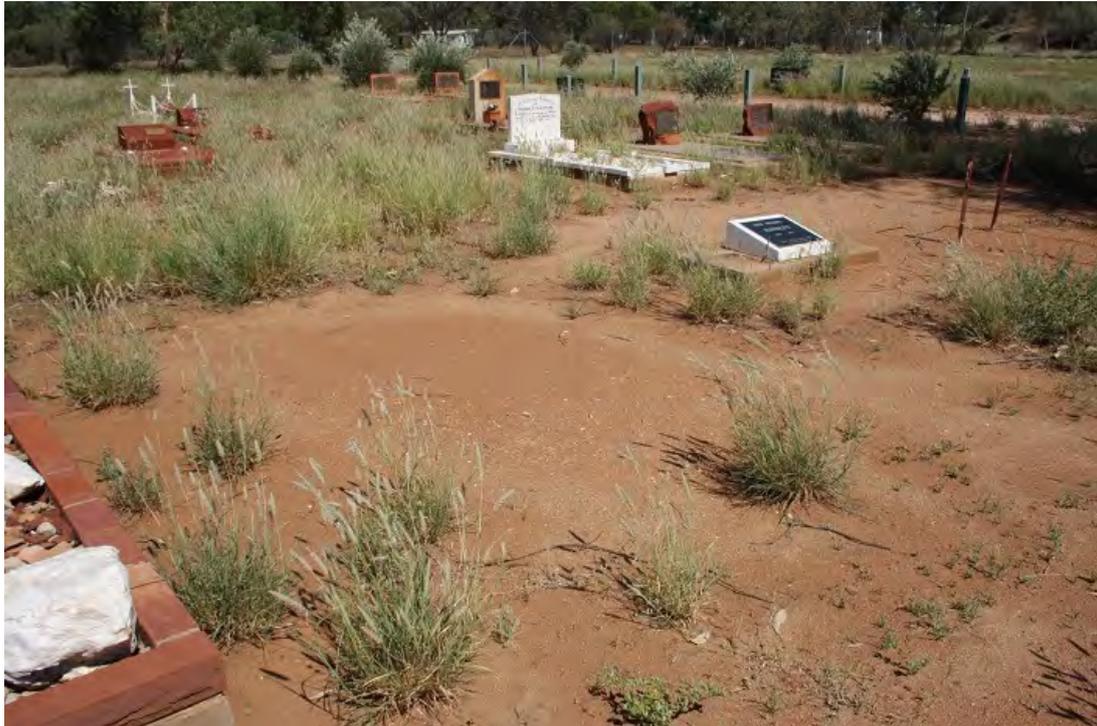
location of some of these burials occurs in the form of slight depressions or slightly raised areas (e.g. Plate 47).

Plate 47. Slightly raised area, indicating the location of an un-marked burial, Section 8B Row C.

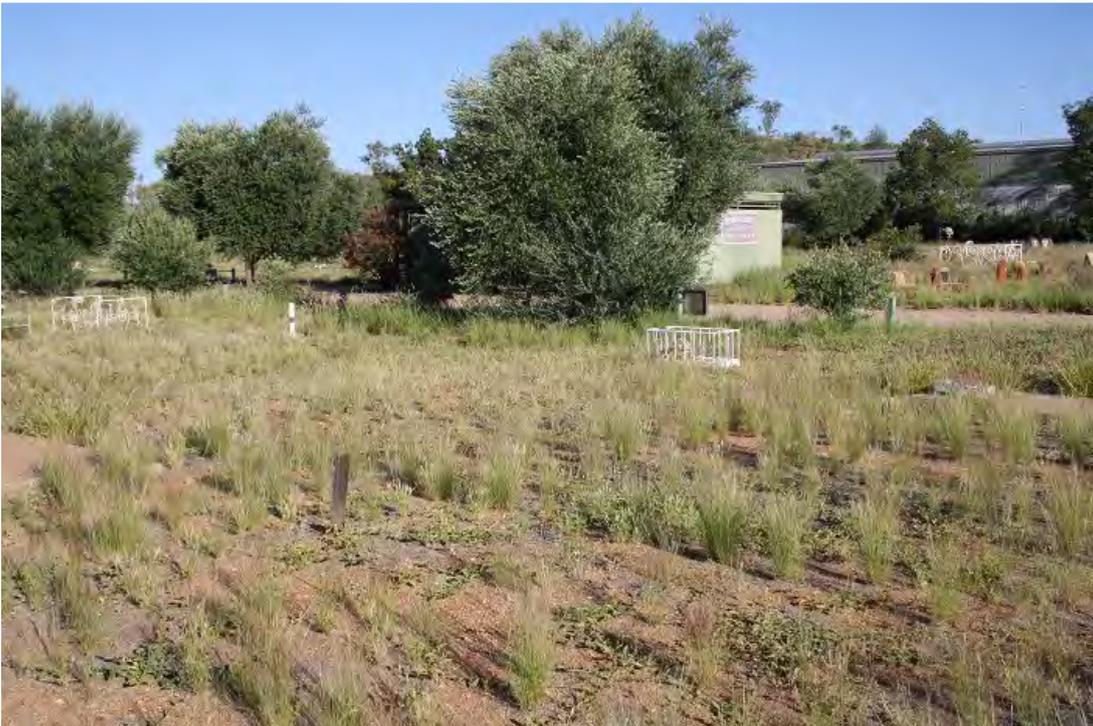
One grave marker in Section 2B Row F consists of a single upright timber post at the head of a raised area of earth (Plate 48).

Plate 48. Simple timber post (middle foreground), Section 2B Row F.

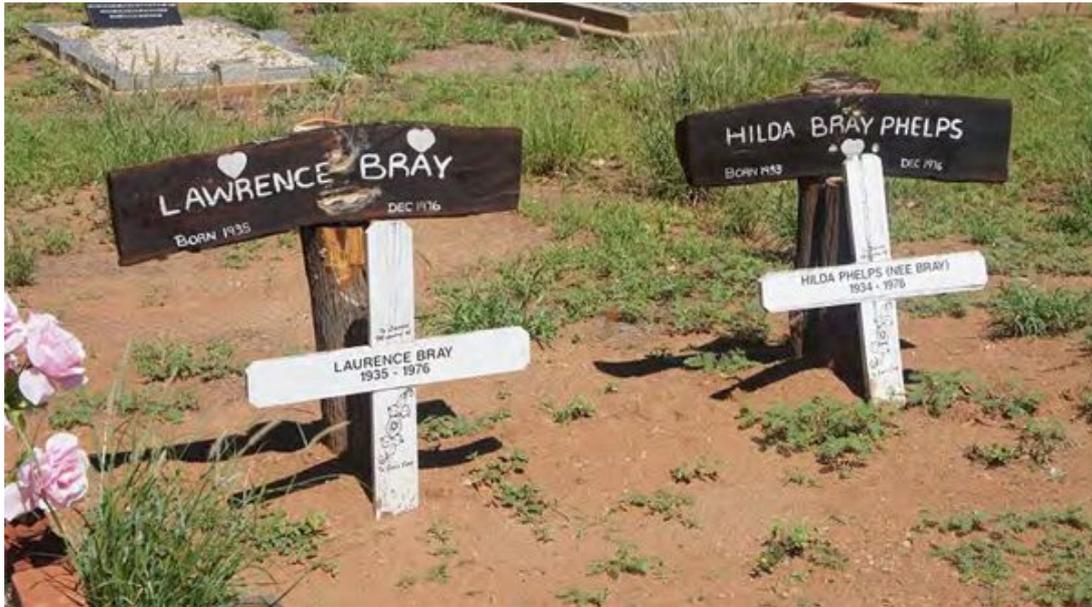
Some graves are marked with simple upright crosses or T-shapes, made of either wood or metal. The wooden crosses include white painted wooden crosses which bear the name of the individual; these appear to be of a standardised size and form and were provided to families with limited financial means. There are also more recent bush timber crosses and T-shapes, which include carved and painted inscriptions. Both are vulnerable to termite attack, but particularly the earlier white painted crosses (Plate 49). Crosses can occur as a single monument, or in conjunction with grave surrounds and/or furniture.

Plate 49. Example of earlier white painted wooden crosses and more recent bush timber markers for Bray family members' graves Section 5B Row H.

- many of the Bray family graves are now marked by new bush timber markers, in addition to retaining the earlier white painted timber crosses;
- the simple bush timber cross marking Kylie May McGuirk's grave has been replaced by a simple metal cross and inscribed plaque;

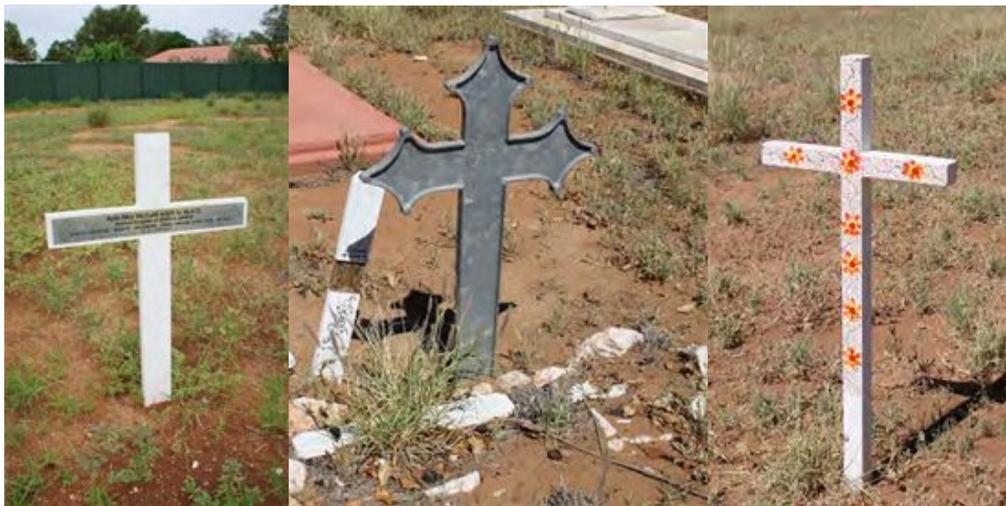
The metal crosses take various forms, from simple markers to more elaborate designs and may be painted or unpainted (e.g. Plate 50). They can occur as a single monument, or in conjunction with other elements such as lines of stones, and concrete slabs.

Plate 50. Examples of different types of metal crosses.
L-R: Kylie May McGuirk Section 7B Row J; ? Section 5A Row K; Un-named grave Section 7B Row H.

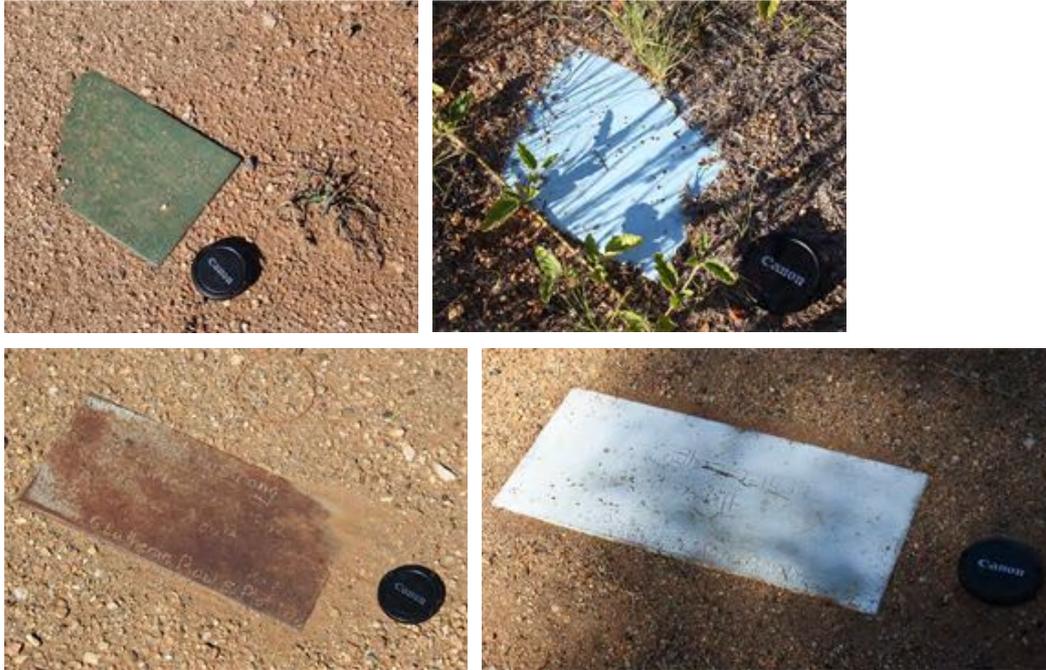
These markers take the form of a single rectangular-shaped piece of enamelled (blue, pink green, white or yellow) sheet metal, set flush into the ground (e.g. Plate 51). As they are set flush with the ground surface they are largely invisible from any distance and are vulnerable

to accidental damage from vehicular and pedestrian traffic. Some of these sheet metal markers retain the remains of inscriptions, now barely legible, and others have rusted considerably although the etched inscription can still be read. There are also remains of plastic tile markers in Sections 7A and 8B.

Plate 51. Examples of different types of enamelled sheet metal markers. Clockwise from top left: Un-named grave Section 4 Row D; Un-named grave Section 2B Row C; [illegible] Smith grave Section 6 Row B; [illegible] Armstrong grave Section 6 Row E.

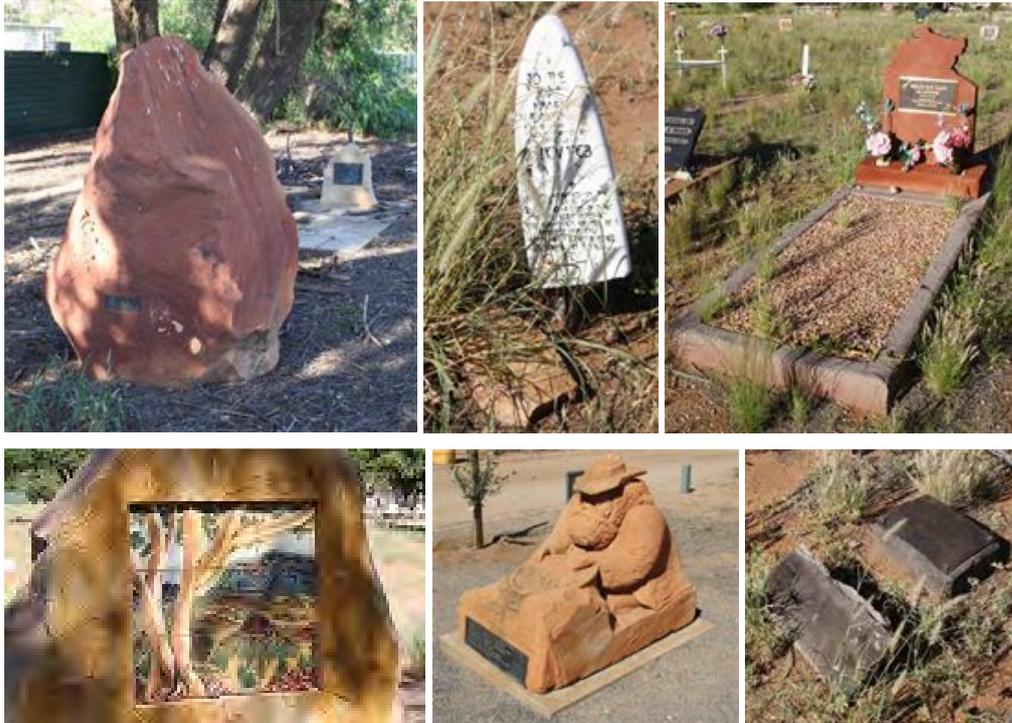
- Harold Bell Lasseter’s grave marker - a sandstone sculpted figure of a bearded man panning for gold. The sandstone has begun to erode, particularly around the hat where the edges have been broken off; and

- Fay Reidy’s grave marker - in 2013 this marker comprised a small wooden log spiked into the ground with a simple brass plaque with inscription attached to the top of the log; in 2018 the plaque has been placed on a small concrete plinth although the wooden log has been retained.

Plate 52. Examples of Informal/Vernacular headstones or monuments.
 L-R from top row: Bob Buck's grave Section 1 Row G; Mary Weaving's grave Section 5B Row C; Nellie May Dann's grave Section 2B Row C; detail of Albert Namatjira's headstone Section 6 Row B; Harold Bell Lasseter's grave Section 3 Row C (2013 image); Fay Reidy's grave Section 5B Row C.

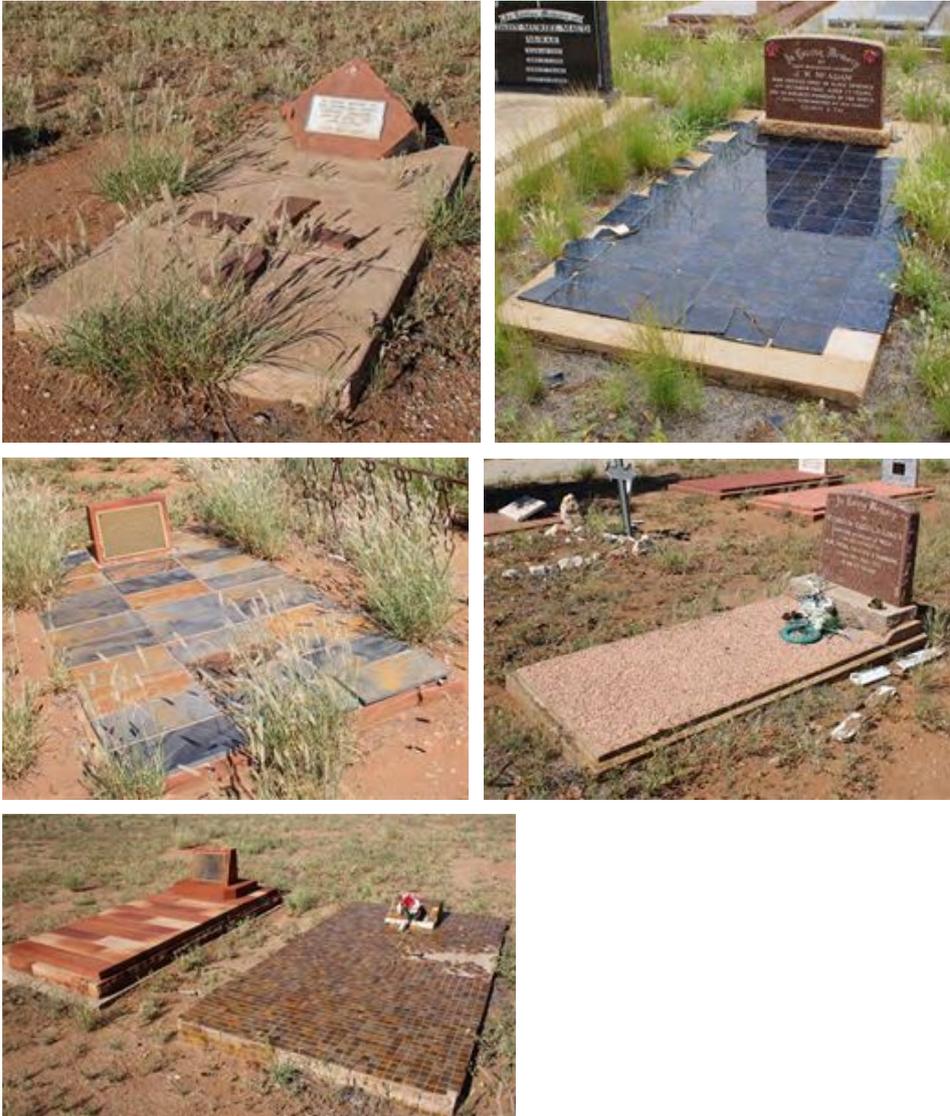
Many of the graves in the Cemetery are marked with slabs. These occur in conjunction with headstones, grave surrounds and grave furniture or as stand-alone markers. Most comprise a simple rectangular concrete slab, however many have additional treatments and/or grave furniture (Plate 53). For example:

- the concrete slab forming part of Stephen Kilgariff's grave marker, includes a cross formed of bricks set into the surface of the slab;
- the concrete slabs forming part of J.W.McAdam's grave marker and Melvie Annie Alice Blacker's marker, have been covered with ceramic tiles. In both cases the tiles have begun to lift and sections are missing;
- slate paving has been used to surface the concrete slab of the grave of David McKenzie;

- coloured gravel has been used to surface the concrete slab on the grave of Gordon Harold Lines; and
- sandstone paving has been used to surface the concrete slabs on many graves in the cemetery, including those of Ronald Hedwell, Albert Namatjira, the Bullen family and Hilda Lillian Chase.

Plate 53. Examples of additional treatments to slabs.
Clockwise from top left: Stephen Kilgariff's grave Section 1 Row L; JW McAdam's grave Section 2B Row C; Gordon Harold Lines' grave Section 5A Row K; Hilda Lillian Chase's grave (left) and MAA Blacker's grave (right), Section 4 Row J; David McKenzie's grave Section 8B Row A.

An example of a damaged slab in need of this type of restoration/reconstruction work is Melvie Annie Alice Blacker's grave (Section 4 Row I, see Plate 53). Other grave markers in similar condition, and which require similar restoration work include the graves of:

- David Spence (Section 5B Row B) - lost applied render; and
- JW McAdam (Section 2B Row D, see Plate 53) - lost mosaic tiling.

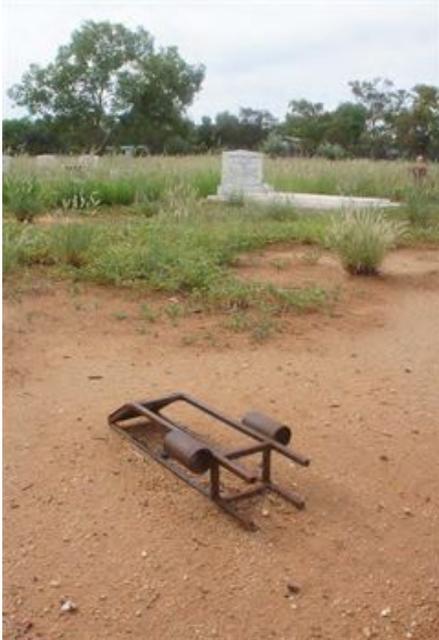
Some grave markers are particularly susceptible to being moved around or removed from the site altogether, such as that for A.J. Sellers' (Tony) grave (Plate 54). Others, such as the enamelled sheet metal markers and plastic tiles set flush into the ground, are vulnerable to inadvertent damage because they cannot be easily seen from any distance.

Plate 54. A.J.Seller's (Tony) grave marker
Section 8B Row B.

Part 4.1.4a of the Conservation Plan noted that some grave markers, particularly smaller markers or surrounds that are relatively portable, and items of grave furniture, are particularly susceptible to vandalism (theft and damage) as well as mischievous re-location within the Cemetery. An example of this type of marker is the metal marker for A.J.Sellers' (Tony) grave (refer Plate 54). Other items, because of their setting flush with the ground surface are vulnerable to accidental damage. Items that are particularly vulnerable to damage (dislodgement, destruction) or loss (theft) include timber items, the earlier metal "Reserved" signs and earlier concrete plot markers, loose enamelled sheet metal markers (various colours), and plastic tiles.

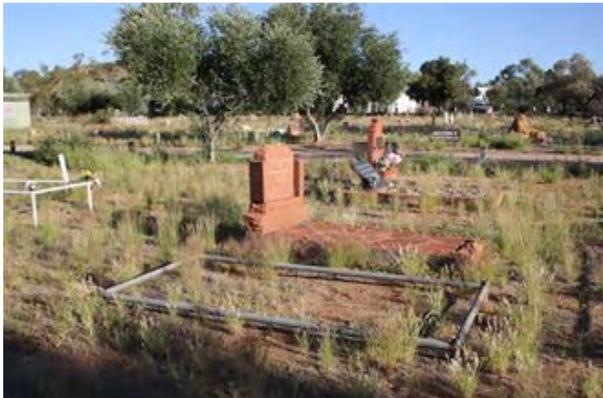
Grave surrounds in the Cemetery also vary considerably. In some cases the grave surrounds form the only marker (e.g. see Plate 55) but in most cases they occur in conjunction with grave furniture, slabs, headstones and other monuments. Metal, brick, concrete, sandstone, timber, plastic and other materials have been used as grave surrounds in the form of fences or low borders.

Plate 55. Simple metal pipe grave surround, Un-named
grave Section 2B Row C.

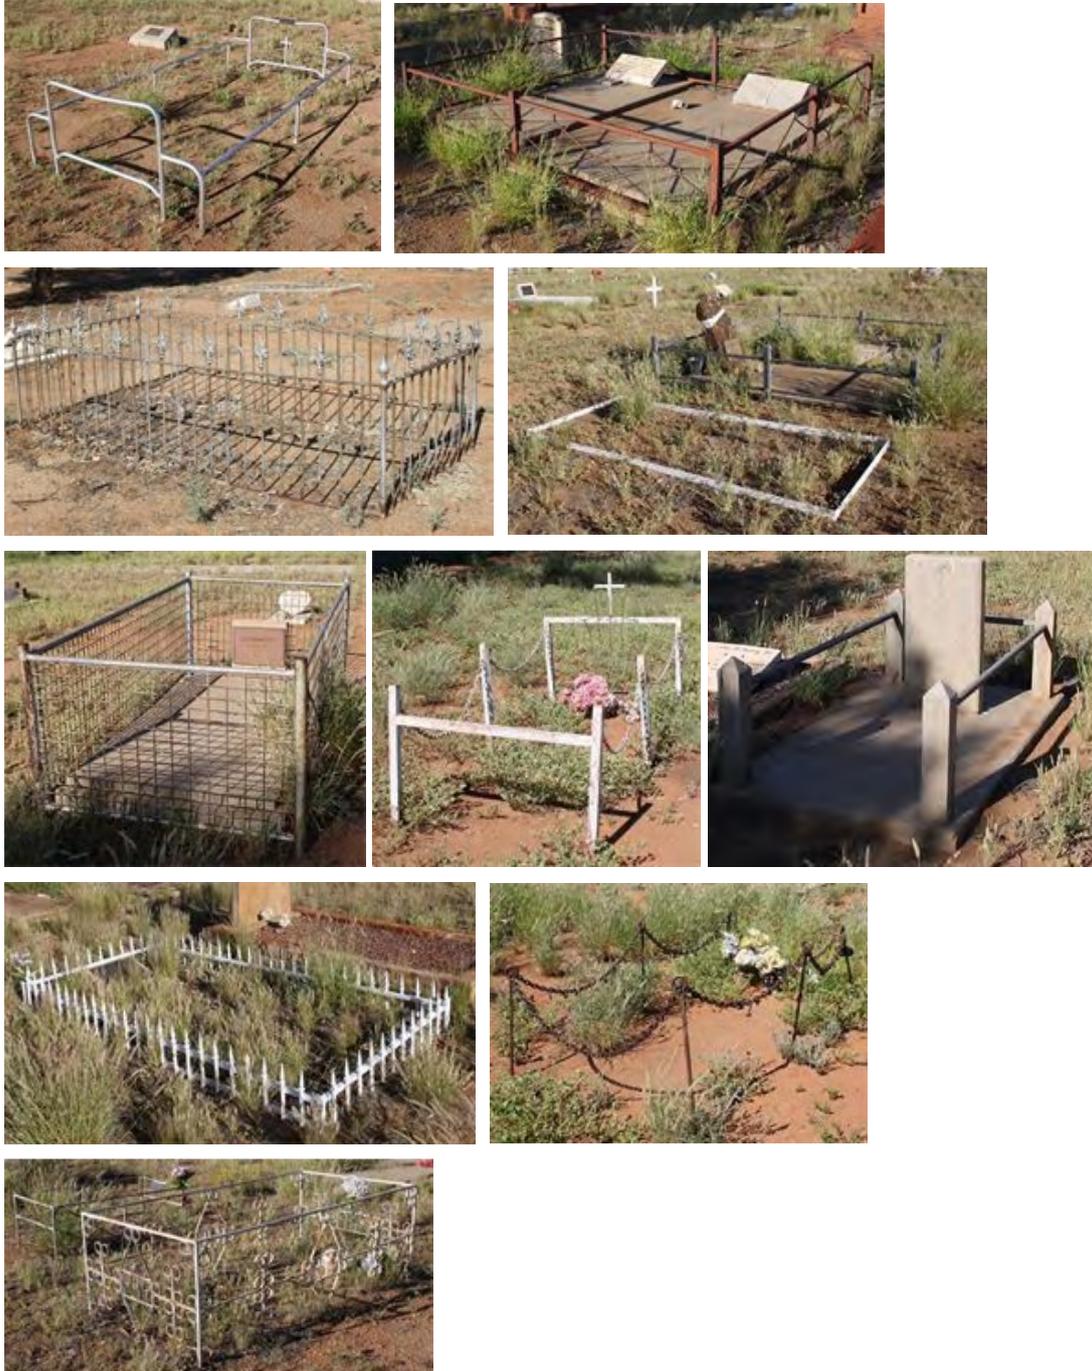
Metal fencing includes examples of fabricated cold steel pipe, wrought and cast iron fencing, steel mesh fencing, low metal rails, aluminium railing, metal chain and post fences, and range from simple unadorned surrounds to ornately detailed fences. Concrete and metal post-and-rail type fences also surround some graves (Plate 56).

Plate 56. Examples of grave surrounds (metal fencing). L-R from top: Frank Sweeney's grave Section 1 Row K; Nicker family Section 2B Row B; grave Section 7A Row B; graves in Section 2B Row E; grave in Section 1 Row K; grave in Section 6 Row I; grave in Section 4 Row A; grave in Section 2B Row F; grave in Section 8B Row F; graves in Section 2A Row I.

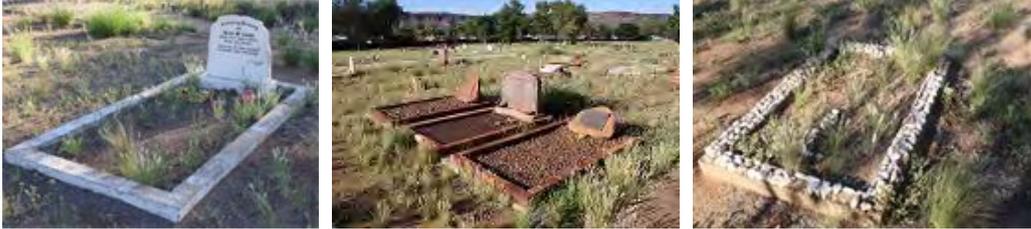
Other grave surrounds consist of low brick, concrete or sandstone block borders some of which are left bare, others are in-filled with additional earth, concrete, variously coloured gravels, rocks, sandstone pavers or white quartz pebbles for example (Plate 57).

Plate 57. Examples of grave surrounds. L-R: Jean McLeod's grave Section 2B Row A; Petrick family graves Section 2B Row D; Un-named grave Section 2B Row A.

- Jean McLeod (Section 2B Row A);
- Florence Marguerite Nichols (Section 2B Row B);
- Allan Spencer (Section 3 Row E);
- George Frederick Young (Section 3 Row F);
- Roger “Pom” James Kendall (Section 5A Row I; see Plate 60);
- Tilly Miller (Section 5b Row J);
- Michael O’Brien (Section 1 Row A);
- Jess (Section 2B Row A);
- Jack William(?) (Section 6 Row A).

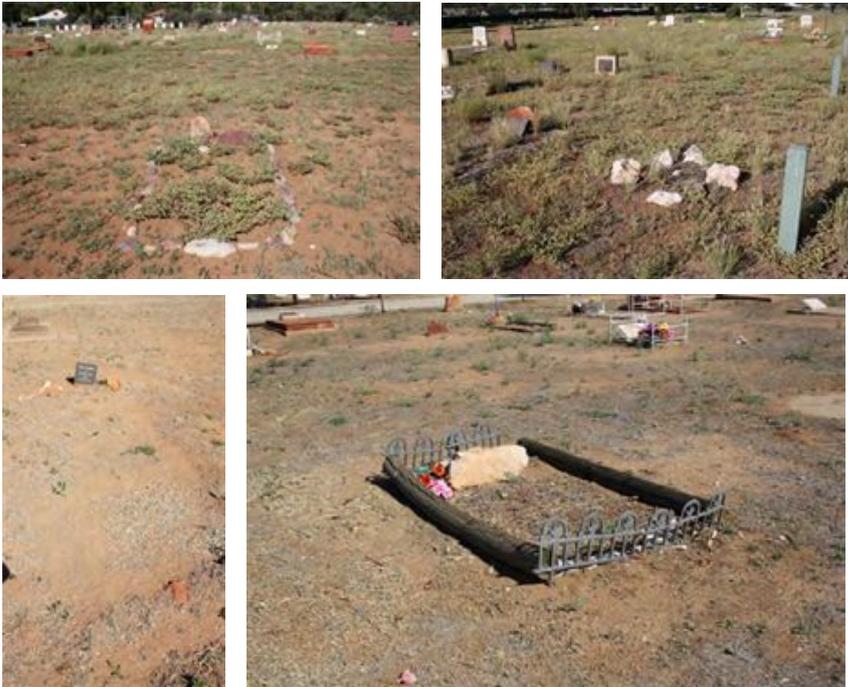
Less formal grave surrounds also occur (e.g. Plate 58), such as that marking Colin Hope's grave, whereby various stones have been arranged in an oval shape to define the plot, or smaller circles of stones like that marking Leo Corbet's grave, most of which have now disappeared, or the small circle of white quartz rocks in Section 1, Row B. Timber surrounds are rare in the Cemetery; one grave is edged with treated pine logs, while in 2013 another grave had timber rails but these could not be located in 2018.

Plate 58. Examples of less formal grave surrounds. Clockwise from top left: Colin Hope's grave Section 5B Row D; Un-named grave Section 1 Row B; grave Section 2A Row I (2013 image to show detail more clearly); Leo Corbet's grave Section 5B Row E (2013 image used to show greater detail).

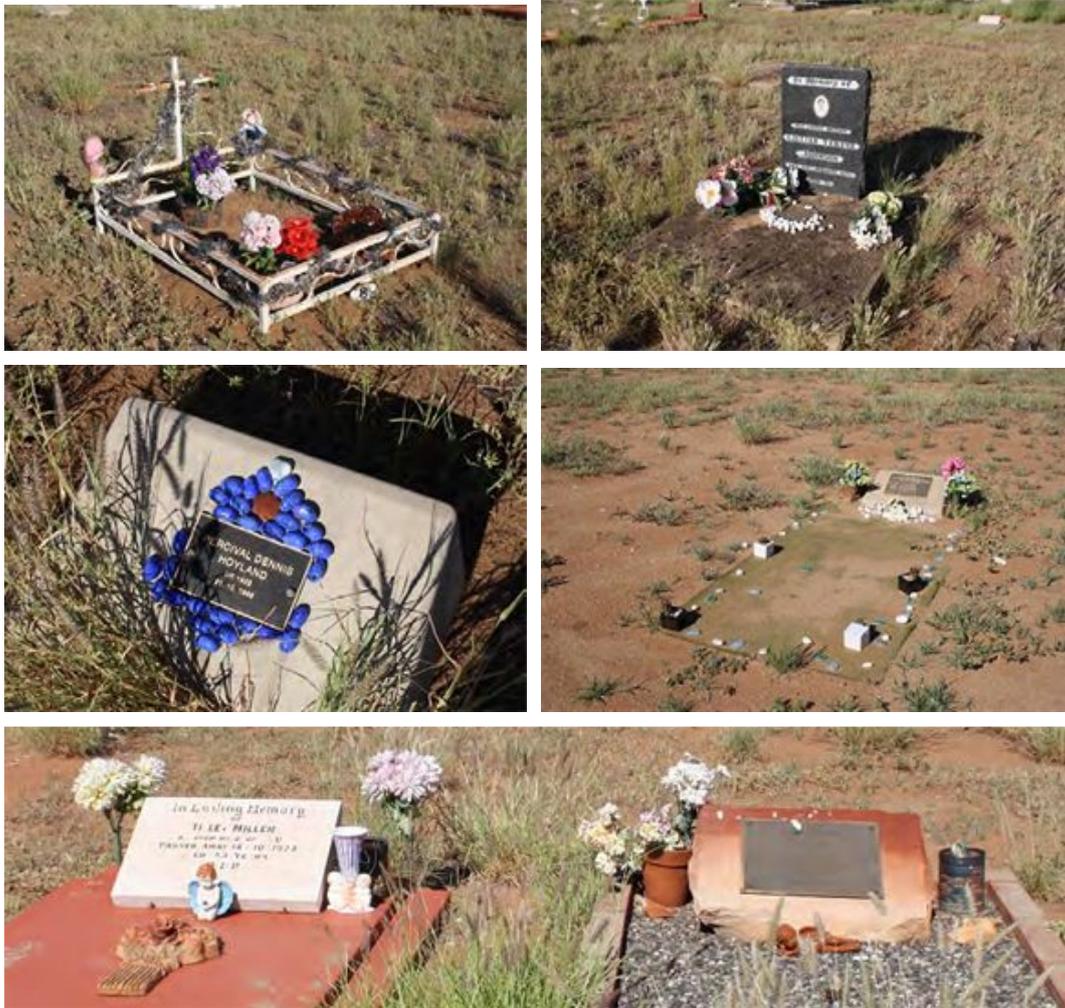
Plate 59. Examples of grave furniture.

The most common type of grave furniture in the Cemetery consists of artificial flowers, however vases, flower pots, painted powdered milk and other tins, glass domes, pebbles, tiling (usually affixed to concrete slabs), coloured glass balls, shells, figurines, portraits of deceased persons, solar lights, pot plants, and carpet also occur (Plate 59). In some cases it is only grave furniture, such as artificial flowers in a vase or pot that forms the burial marker.

Clockwise from top left: Grave in Section 2A Row H; Lillian Terese Johnson's grave in Section 2A Row H; Barbara Ann Wilson-Nixon's grave Section 4 Row H; graves of Tilly Miller (left) and Kingsley Roy Tilmouth (right) Section 5A Row J; Percival Denis Hoyland's grave Section 3 Row L.

It was apparent in the course of revisiting the Cemetery in 2018 and comparing 2013 and 2018 photographs that some grave furniture had been damaged and/or disappeared. For example, some of the small glass balls from Percival Denis Hoyland's grave have disappeared along with the star that was formerly attached to the cement headstone (Plate 66). The flower pot which marked a grave located towards the northern end of Row H in Section 1 has also disappeared.

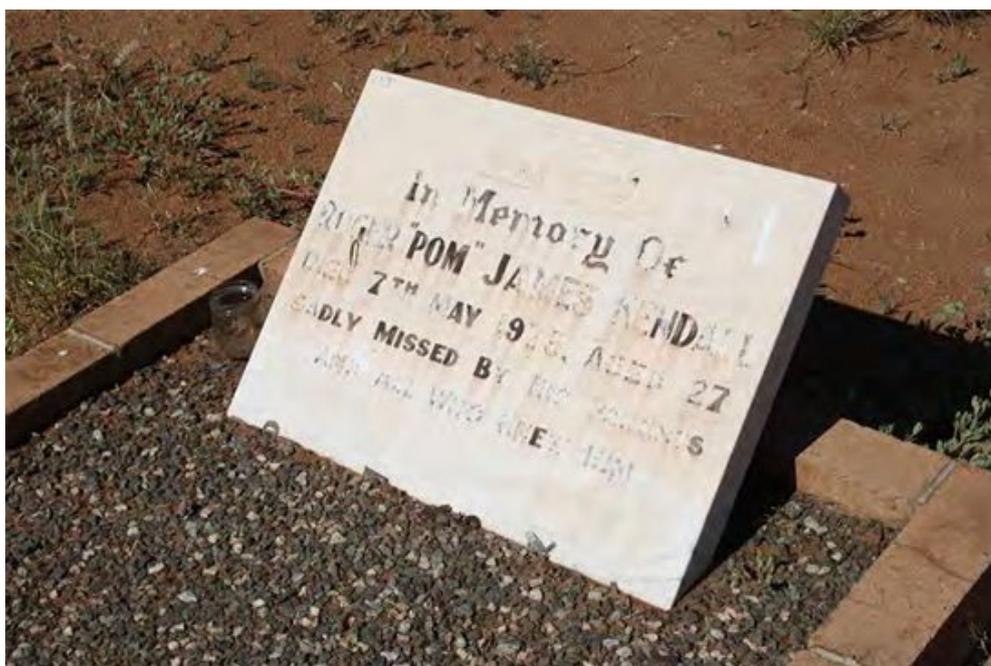
Inscriptions in the Cemetery occur on plaques and are also etched into the headstone material or otherwise attached to the headstone or other monument. They vary greatly in terms of their font type, size, style and execution. Some are raised proud of the surface, others are inset. Some of those that have been etched into the headstone have then been painted or filled with gold paint/gilt. In other cases the lead lettering is attached by small spikes (keys) into the surface of the marble (Plate 60). The content of the inscriptions in some cases is simply limited to a name and dates of birth and death. Others range from simple loving statements by relatives and/or friends to lengthy tributes. Still others attribute the cause of the death, for example Colin Milnes who 'PERISHED FROM HEAT EXHAUSTION' in 1957, indicating that even in this era, the Centre was still a harsh outback environment, quick to claim the lives of those who didn't take care.

Plate 60. Example of lead lettering attached by small spikes (keys) into the marble surface, Roger "Pom" James Kendall's grave Section 5A Row I.

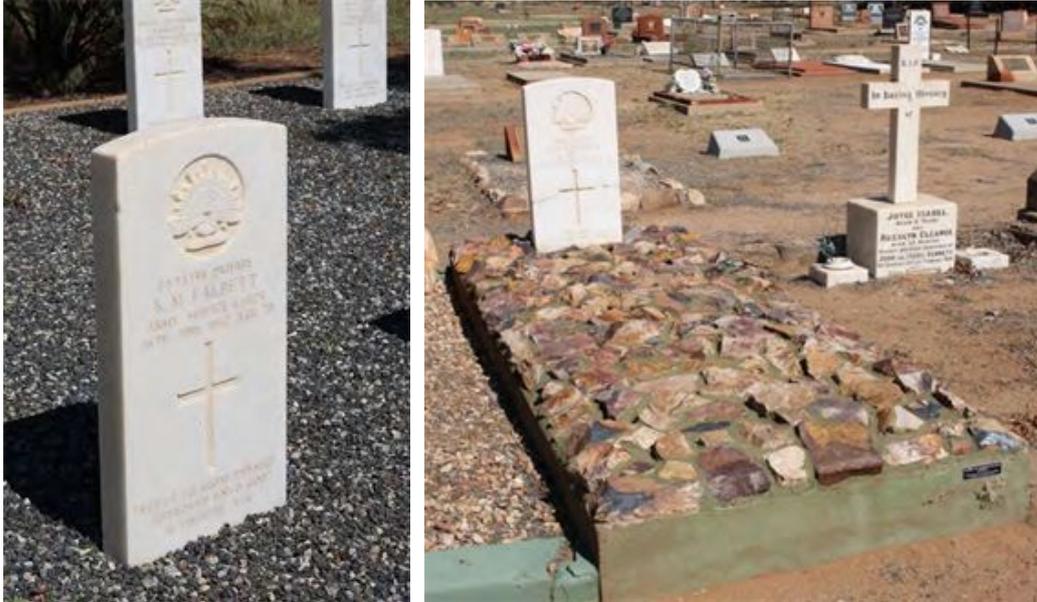
The design of the Cemetery adheres to the principles for war cemeteries adopted by the Commonwealth War Graves Commission and described in part 2.2. above. Each grave is marked by a white marble headstone, of uniform size and design. Each headstone includes the Navy, Army or Airforce insignia as appropriate, below which is an inscription stating the deceased's service number, rank, name, battalion/unit, date of death, and age at death. Below this inscription is an etched cross and underneath this is an individual inscription chosen by relatives or the OAWG (Plate 63). These graves are bordered by a low raised cement wall approximately 300mm high and in-filled with blue metal. Native plants have been planted along the western and northern edges of this Cemetery. A brickwork pillar capped with cement is located mid-way along the eastern boundary of this Cemetery. It bears a bronze plaque that identifies this Section as the "Alice Springs War Graves Plot" and a statement indicating that it is maintained on behalf of the Commonwealth War Graves Commission by the Office of Australian War Graves. The pillar appears to have lost what is believed to have been another plaque from the top capping.

Plate 63. Detail of war graves. L-R: Detail of K.M. Talbett's grave Alice Springs War Cemetery Section 8A Row A; Jack Kennett's grave Section 3 Row A (2013 image used to show greater detail).

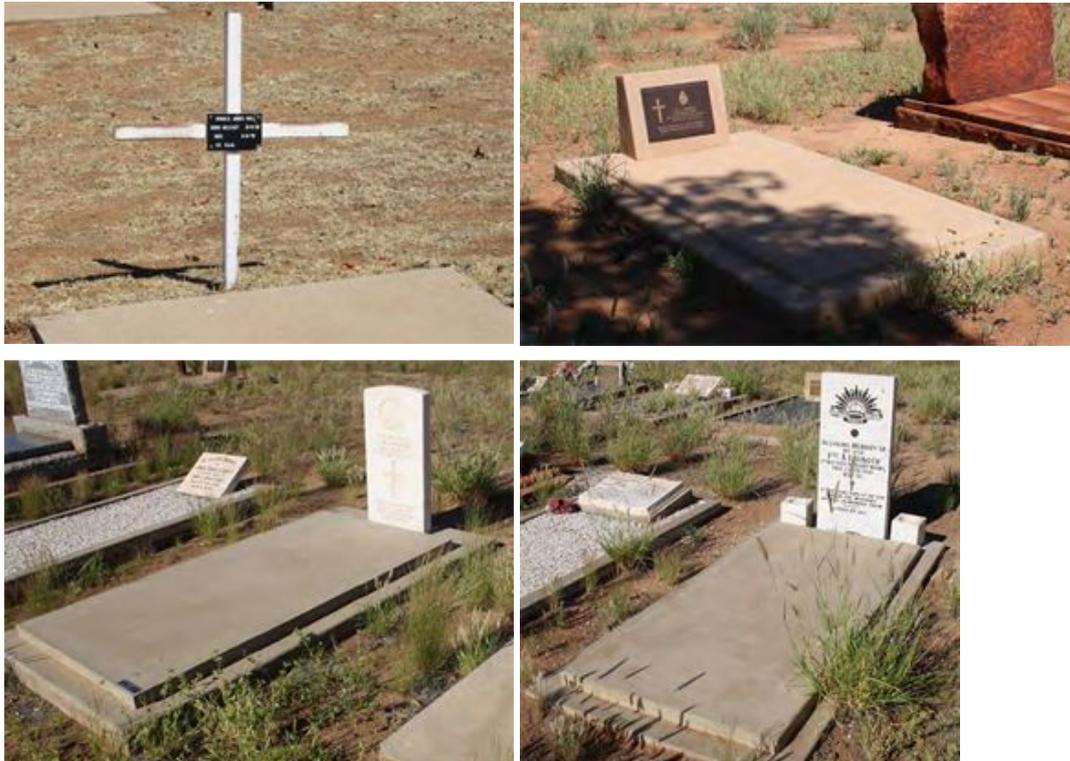
Elsewhere in the General Cemetery ex-service personnel graves that are maintained by OAWG consist of a bronze plaque mounted on a low cement headstone placed at the western end of a concrete slab (Plate 64). The plaque includes a cross, Navy/Army/Airforce insignia as appropriate, with the deceased's service number, rank, name, battalion/unit, date of death, age at death, and short inscription selected by relatives or OAWG. Each of these graves has a small metal tag discretely affixed to the rear of the headstone, indicating that it is the responsibility of the OAWG.

Other ex-service personnel graves have no indication that they are maintained by the OAWG and demonstrate greater individuality although there is a similarity of design evident amongst some of these headstones to those installed by the OAWG (e.g. Pte A.I. Kunoth's grave). Yet others bear no similarity to the OAWG maintained graves at all, for example Ronald Hall's grave, or demonstrate only limited similarity, such as Pte K.R. Tilmouth's grave, shown earlier in Plate 59.

Plate 64. Examples of other ex-service personnel graves. Clockwise from top left: Ronald Hall's grave Section 5B Row H (2013 image to show greater detail); H.L. Dower's grave Section 8A Row H; Pte A.I. Kunoth's grave Section 3 Row D; Major A.E. Gurner's grave Section 3 Row D.

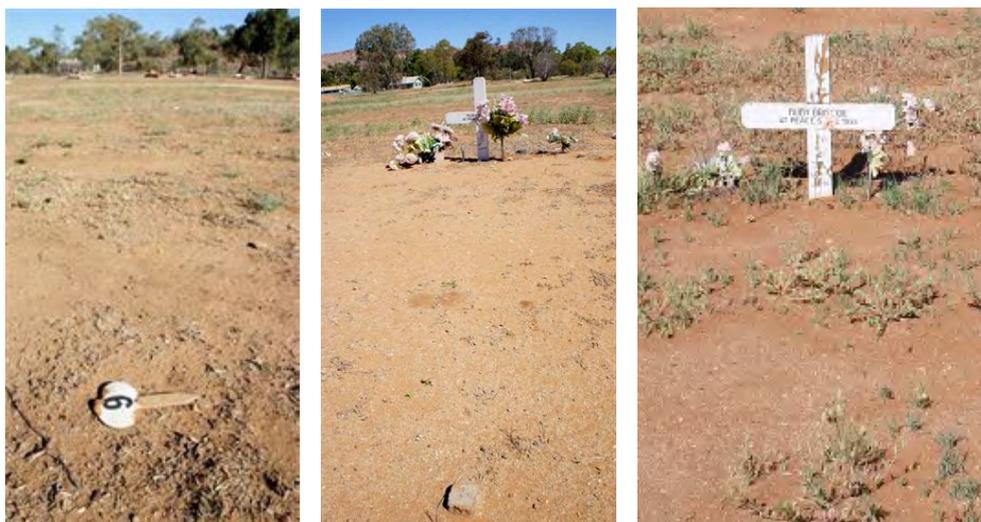
Plate 65. Example of an earlier plot marker present in Section 4 in 2013 but no longer present in 2018 (left); Ruby Briscoe's grave, Section 9 Row C in 2013 (middle) and 2018 (right).

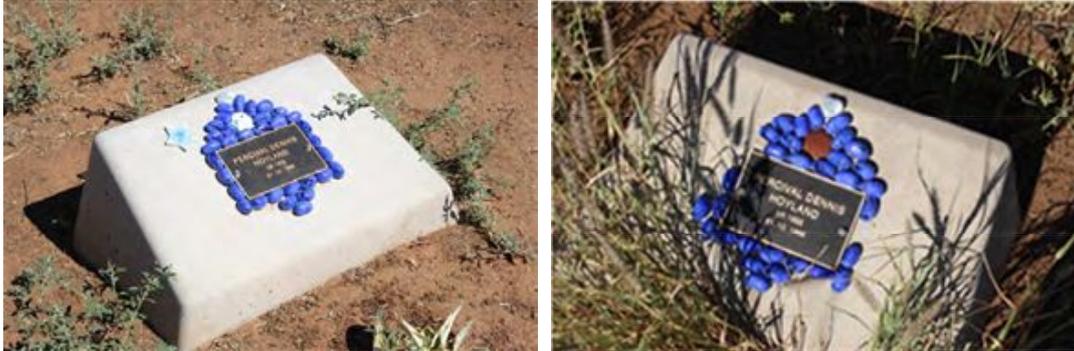
Plate 66. Example of loss of grave furniture, Percival Denis Hoyland's grave Section 3 Row L in 2013 (left) and 2018 (right).

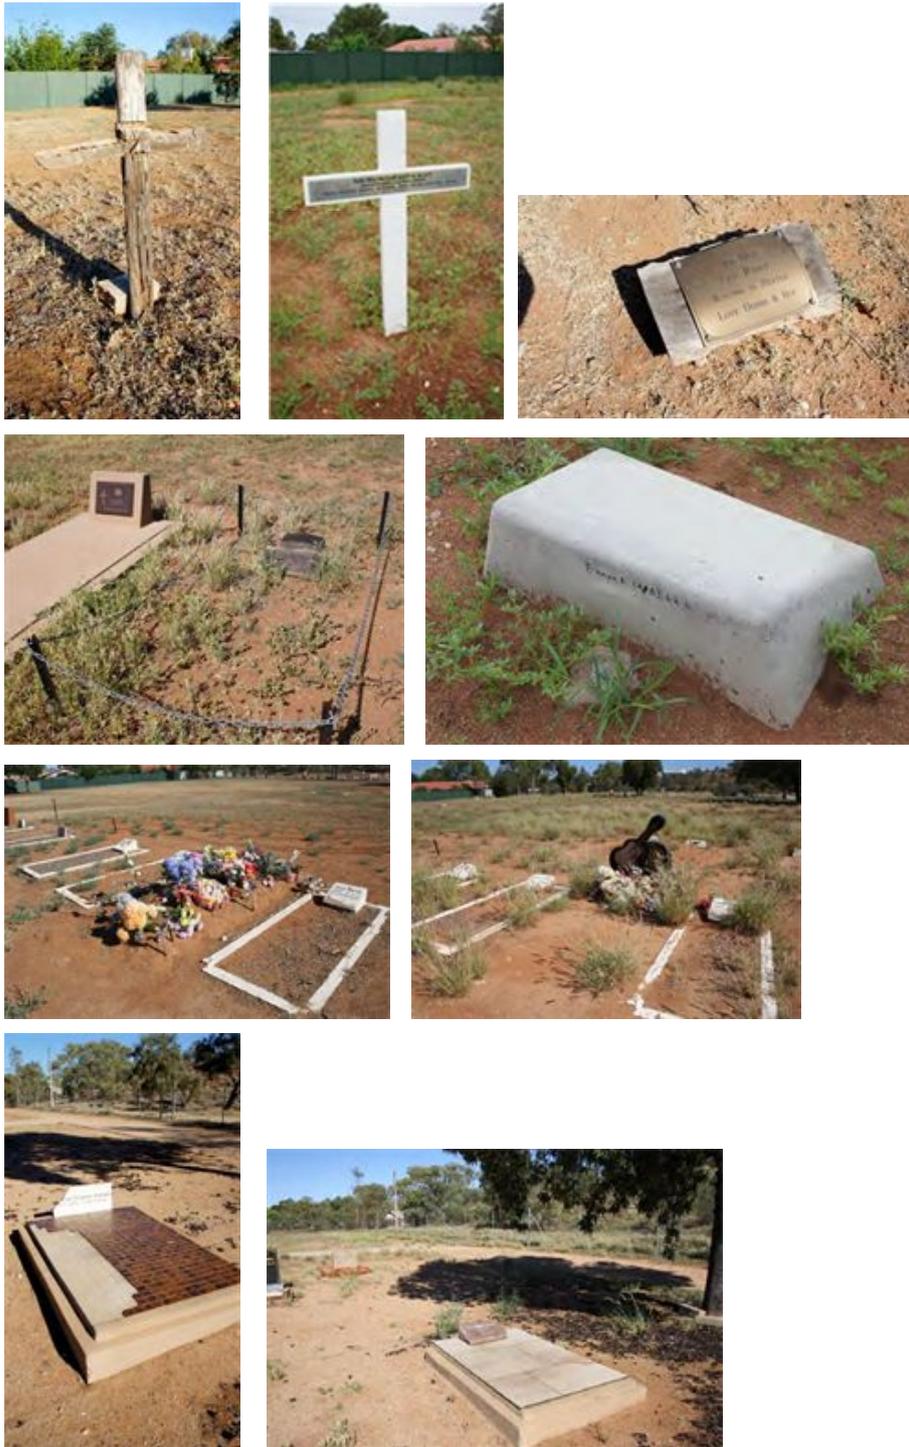
It is clear that between 2013 and 2018 several grave markers have been replaced with new markers, most likely by relatives and/or friends of the deceased (e.g. see Plate 67). For example:

- Gordon William Satour's grave, previously marked by a concrete marker, now has a new headstone;
- Callan Richard Howard's grave has since received a new headstone and tiles to the slab;

- some new concrete markers have been installed in the form of small, simple low headstones that in some cases include the deceased's name; and
- new grave furniture has been placed around Barbara Ann Wilson-Nixon's grave (Plate 68).

Plate 67. Examples of new grave markers, grave surrounds and/or grave furniture. L-R from top: Kylie May McGuirk's grave Section 7B Row J in 2013; ditto 2018; Fay Reidy's grave marker Section 5B Row C in 2013; ditto 2018; new concrete marker for Emma Wallace; Gordon William Satour's grave Section 7A Row C in 2013; ditto 2018; Callan Richard Howard's grave Section 4 Row J in 2013; ditto 2018.

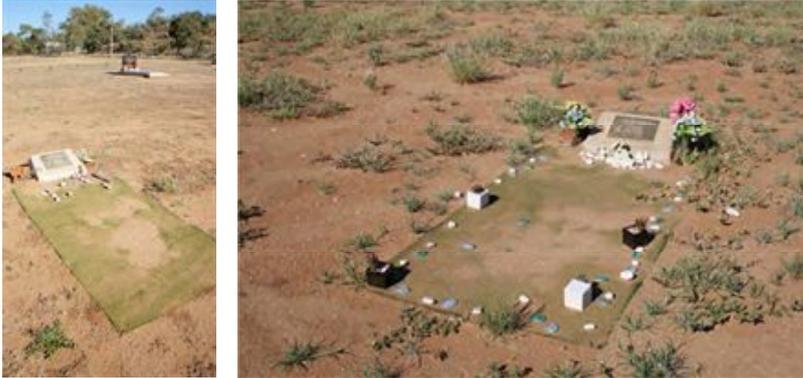
Plate 68. Example of new grave furniture, Barbara Ann Wilson-Nixon's grave Section 4 Row H in 2013 (left) and in 2018 (right).

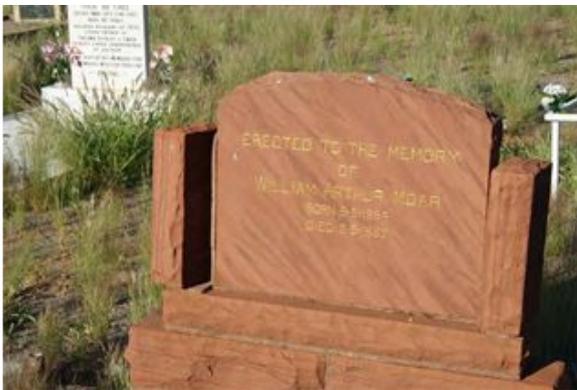
Plate 76. Example of a headstone requiring re-setting, William Arthur Moar's grave Section 2B Row C.
