Technical Services Committee

Business Paper for July 2020

Conservation and Management Guidelines

2018 CONSERVATION PLAN

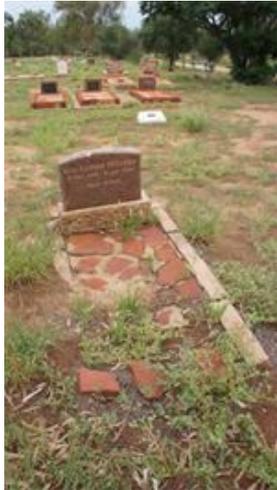
An example of a leaning, but unbroken, marker in need of monitoring and possible re-setting, is that of Dean Gardner Patterson (Plate 77). Other markers in similar condition, and which may require similar restoration work include the graves of Leo Corbet (Section 5B Row E) as well as Giocondo Zoanetti's grave (Section 1 Row B) and another leaning monument in Section 1 Row A.

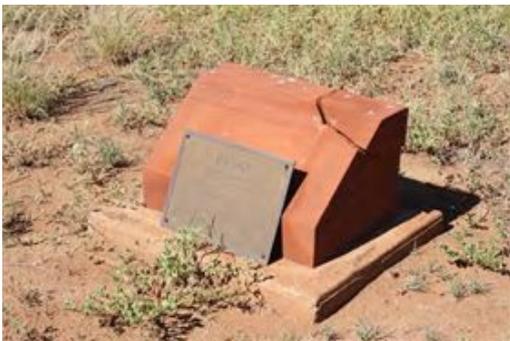
Plate 78. Example of broken headstone, and dislodged plaque, both in danger of being lost, Lottie and Alexander Kerr's grave Section 5B Row B.

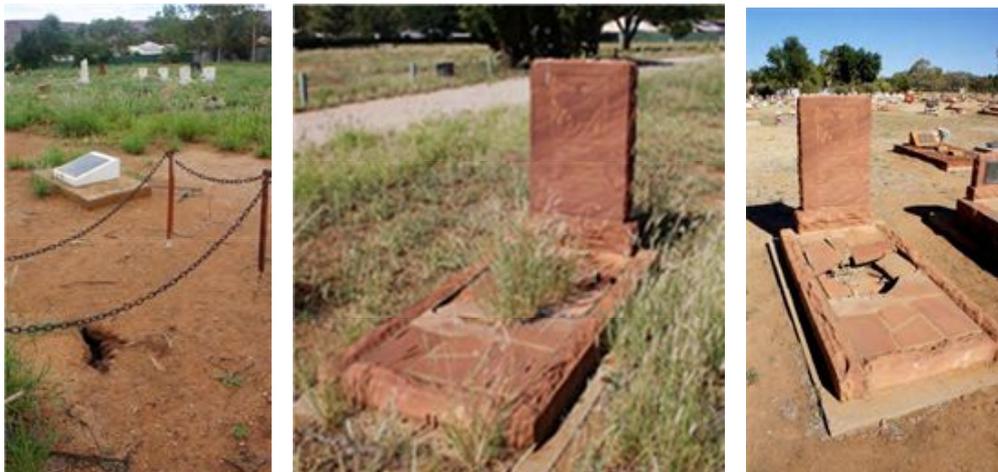
Plate 79. Examples of subsidence. Un-named grave Section 8B Row C (left); Ronald H Hedwell's grave Section 5B Row B where the stonework slab cover has subsided and needs repair (middle) and. 2013 image provided to show greater detail (right).

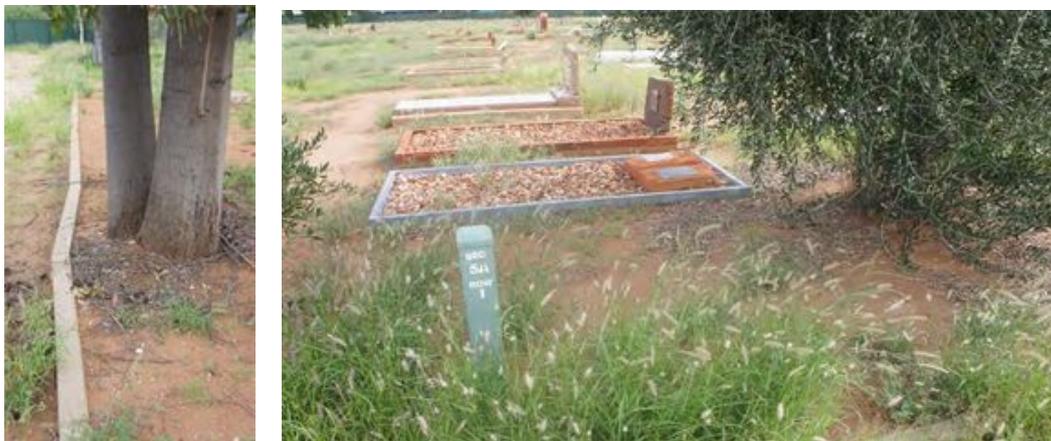
Plate 80. Examples of plantings impacting upon the built fabric of the Cemetery. Kurrajong impacting upon the kerbing, Section 8B southern end of Row F (left); Olive trees planted too close to graves, Section 5A northern end of Row I (right).

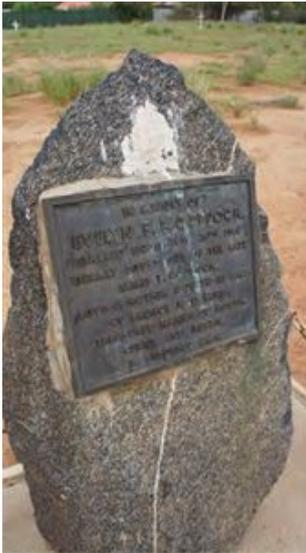
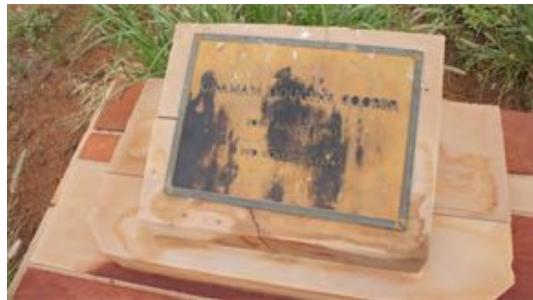
Plate 81. Examples of grave markers that may require stain removal. Evelyn E.L. Coppock's grave Section 7B Row B (left); Graham Douglas Cooper's grave Section 5B Row G (right).

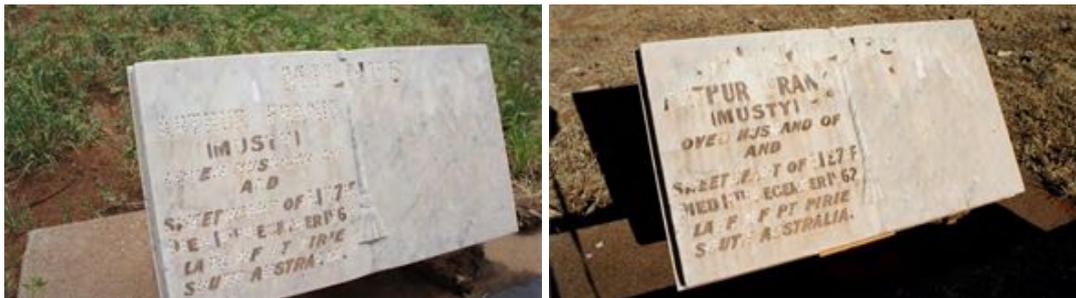
Plate 82. Example of a grave marker in urgent need of re-leading. Arthur Frank (Musty) Milnes’ grave Section 1 Row H in 2018 (left) and 2013 (right). The loss of lettering over the five year period is noticeable.

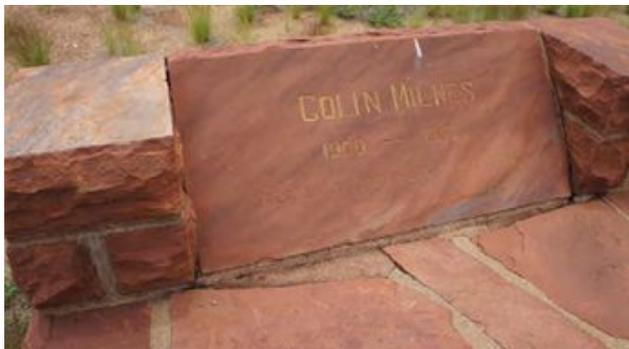
Plate 83. Example of a grave marker in need of repainting of the lettering, Colin Milnes’s grave (Section 2B Row C).

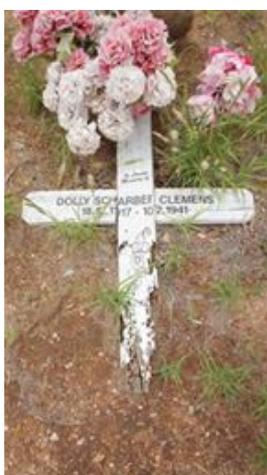
within the Cemetery, they may be treated with a clear, zinc naphthenate preservative, and tung oil, at 5-year intervals. Rusting nail fixings may be touch treated with Fisholene to prevent further deterioration. Examples of timber-work in need of repair is that of Dolly Scharber Clemens (Plate 84). Other monuments in similar condition, and which require similar conservation work include the timber surround to an un-named grave in Section 8B, Row D.
